Attachment 4: Photographs of various TRCA flood infrastructure and projects

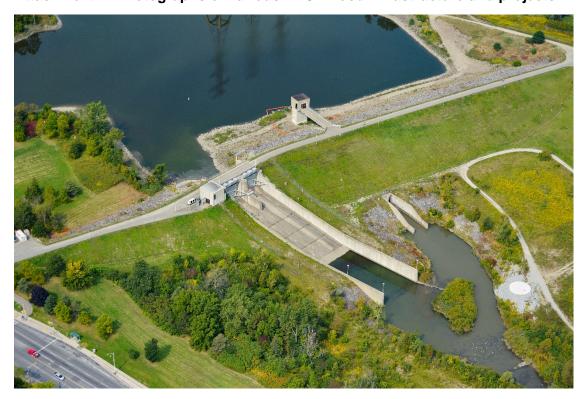
Figure 1 G. Ross Lord Dam carries the highest potential risk of any TRCA dam based on risk to life and property.

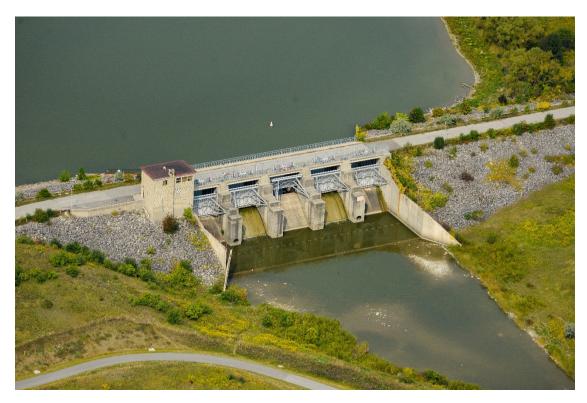
Figure 2 Claireville Dam was constructed in 1963 and requires major maintenance to meet current dam safety guidelines.

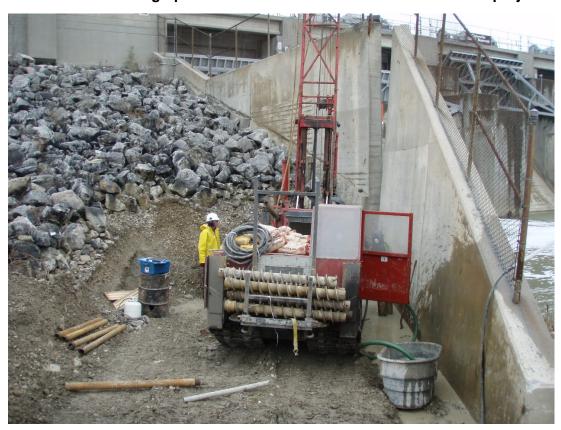
Figure 3 Claireville Dam wing wall settlement investigation.

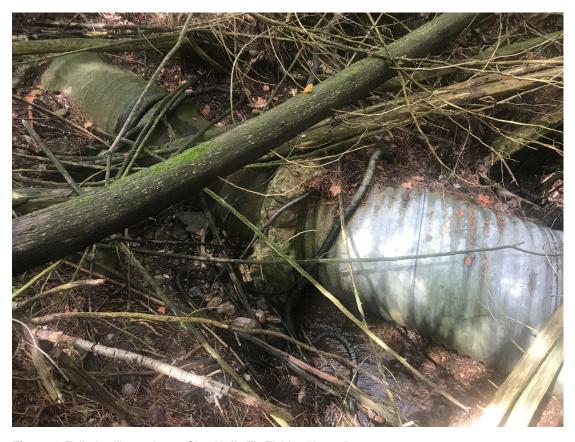
Figure 4 Failed spillway pipe at Glen Haffy Fly Fishing Upper Dam

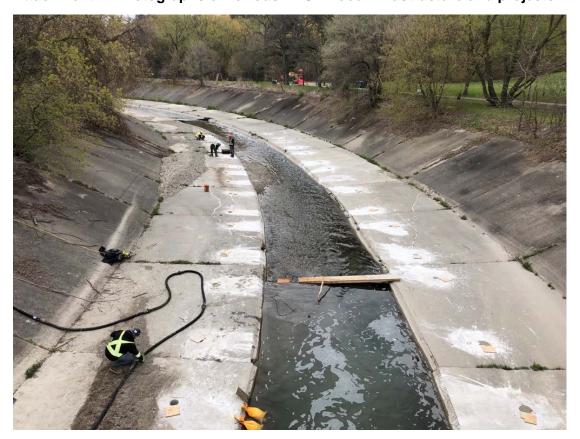
Figure 5 Yonge/York Mills Channel concrete repair in 2020.

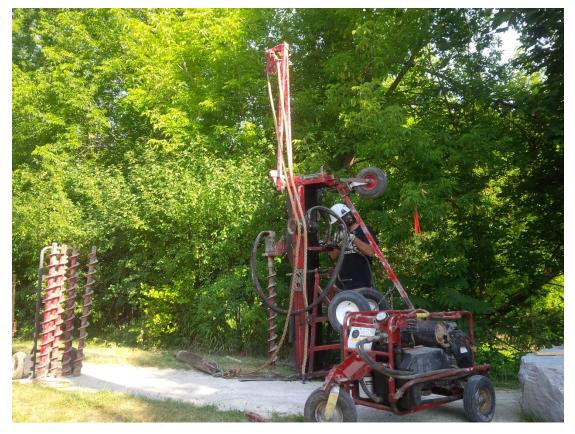
Figure 6 Bolton Berm 2016 geotechnical investigation.

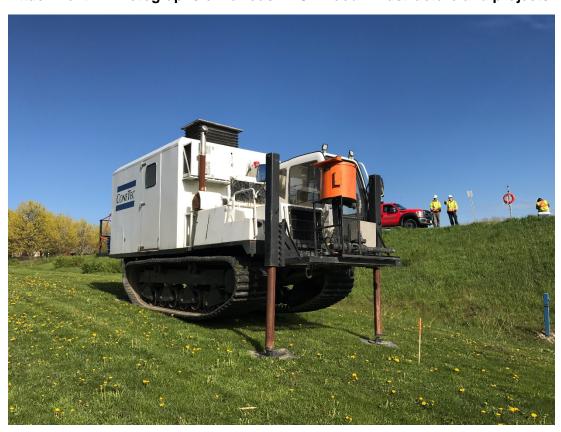
Figure 7 Stouffville Dam undergoing earthquake liquefaction investigation.

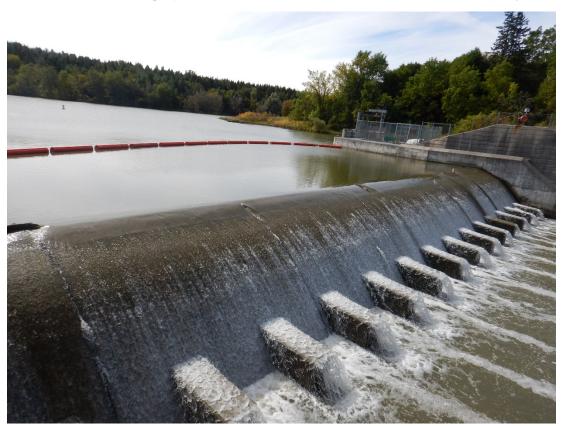
Figure 9 Milne Dam's spillway is too small for extreme floods and requires upgrades to withstand overtopping.

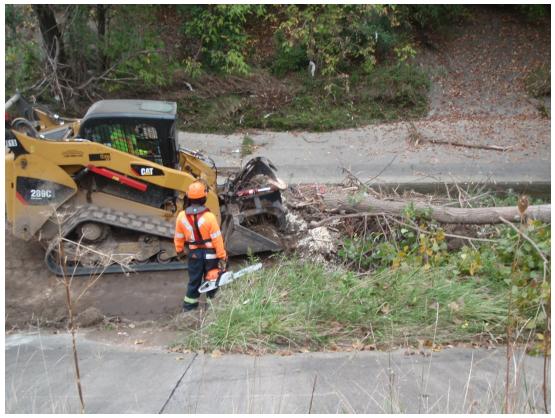
Figure 10 Black Creek Flood Control Channel undergoing major maintenance to restore conveyance.

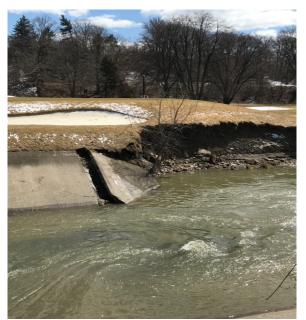
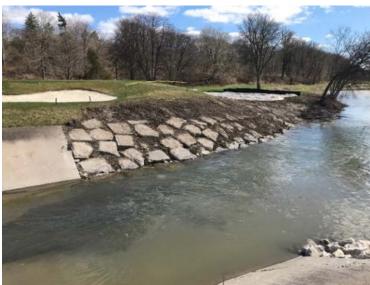
Figure 11 Scarlett Flood Control Channel erosion repair before and after photos.

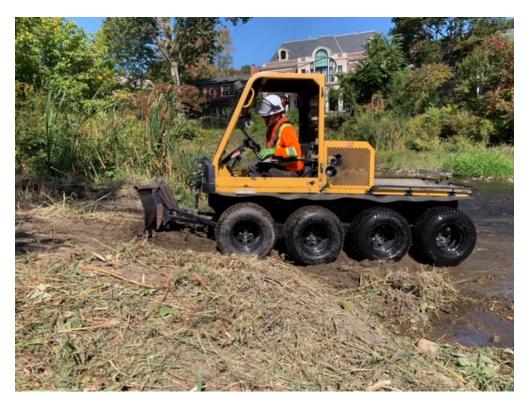
Figure 12 Vegetation removal at Yonge/York Mills Channel as part of TRCA's preventative maintenance program.

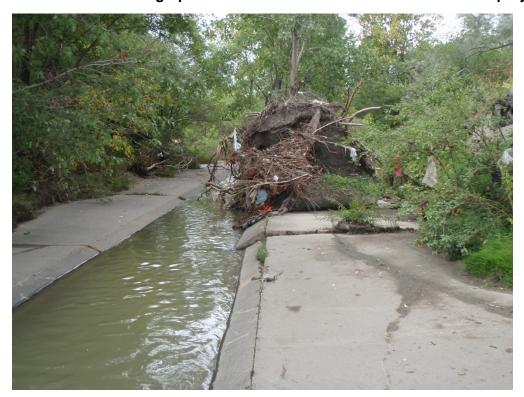
Figure 13 Partially blocked flood control channel at Black Creek.

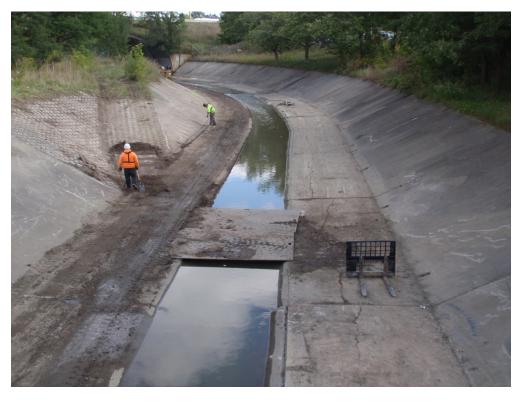
Figure 14 Black Creek Channel after major maintenance (2014).

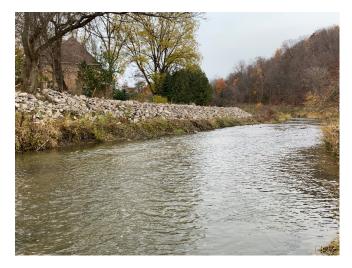
Figure 17 Bolton Berm rip rap installation (2020).
