Toronto Ravine Major Maintenance

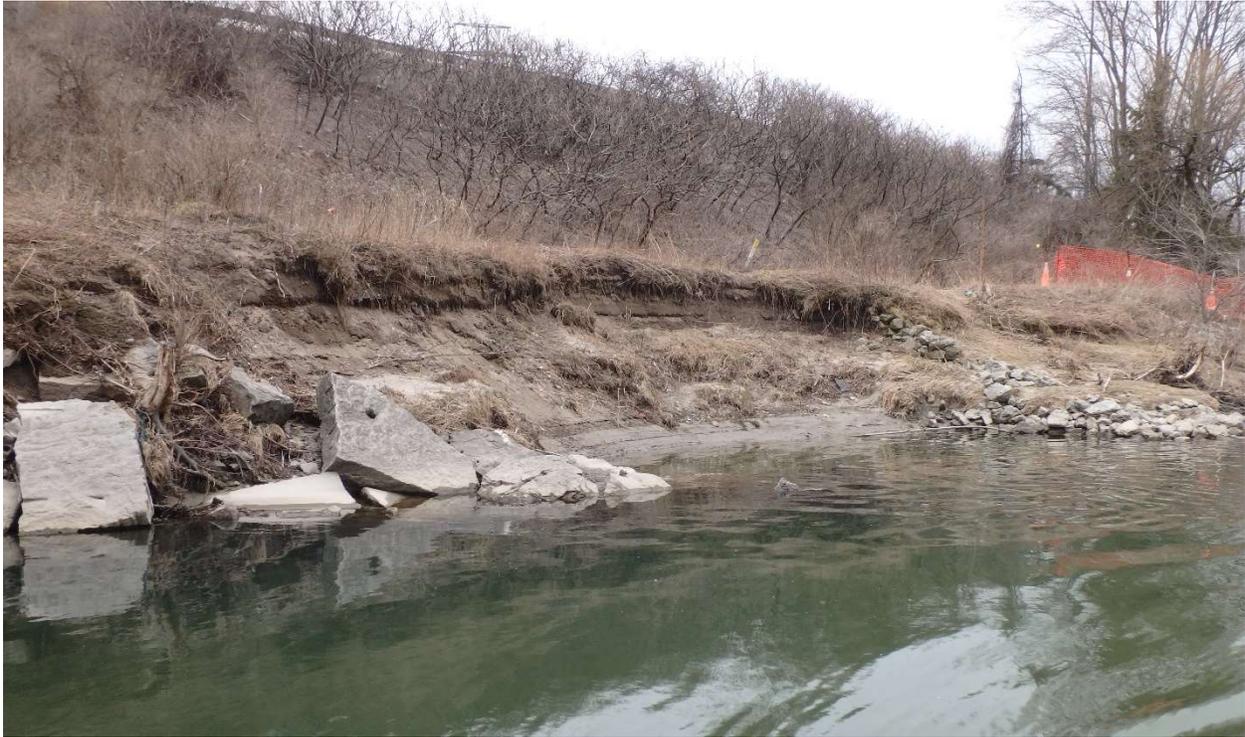
Figure 1. Eroding bank at failed TRCA erosion control asset along the main branch of the Don River, City of Toronto.

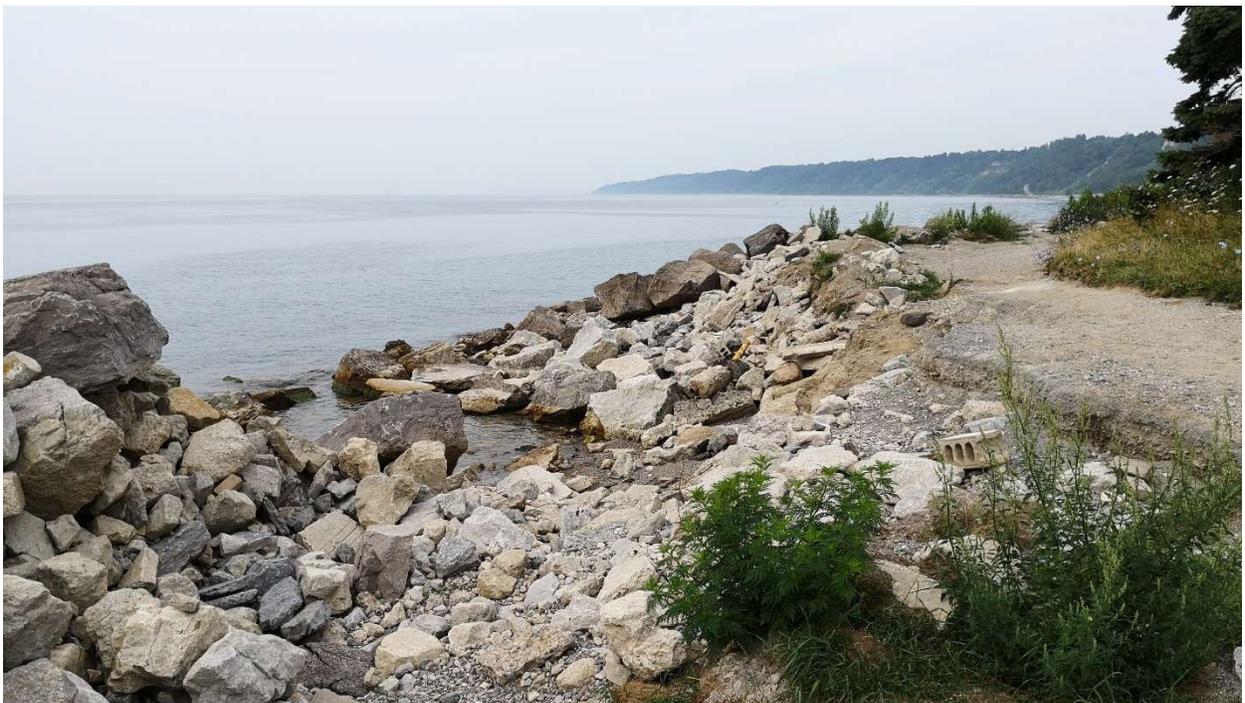
Figure 2. Eroded headland structure in Bluffers Park, City of Toronto.

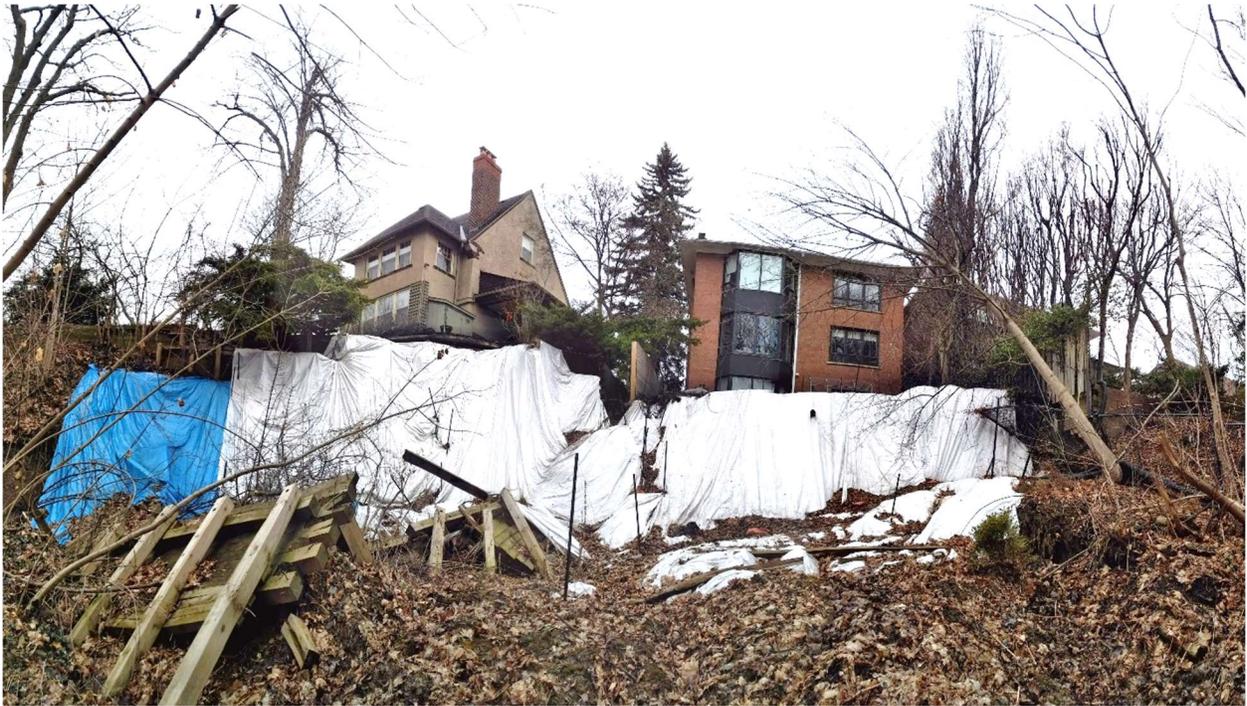
Figure 3. Slope failure at a Valley Erosion Hazard Site in the City of Toronto.

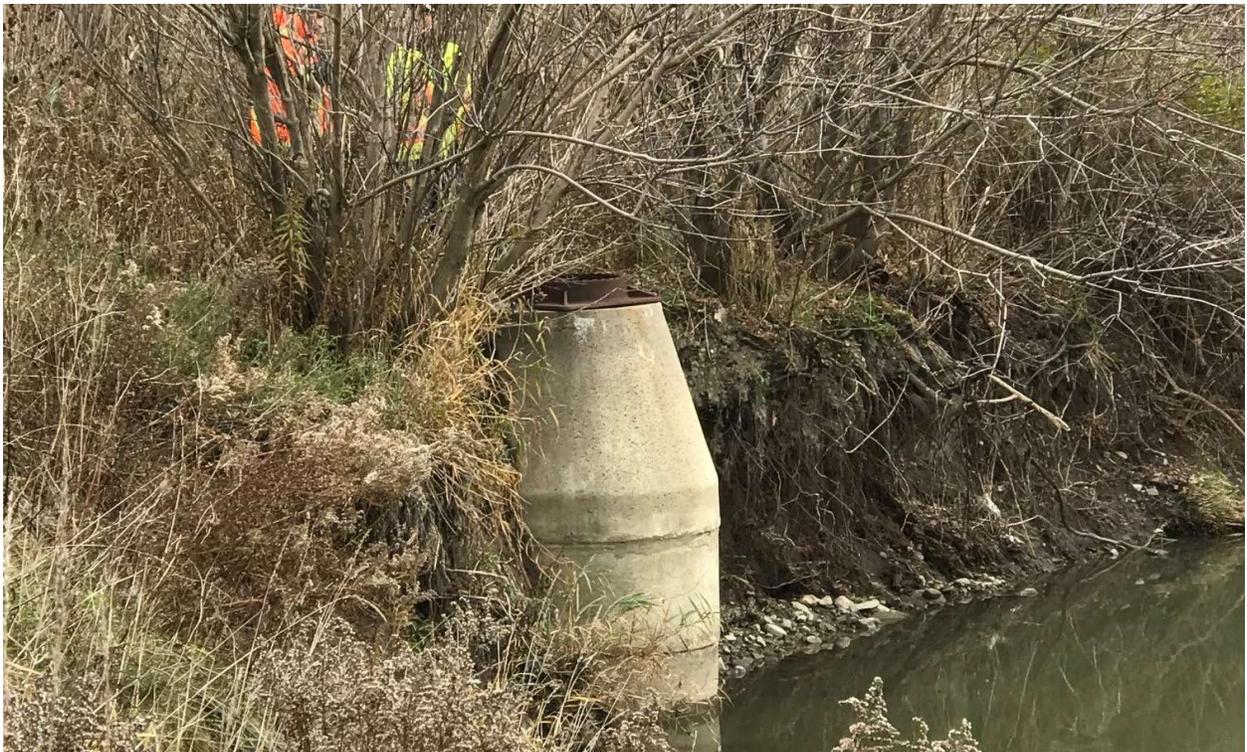
Figure 4. Exposed manhole chamber along Rainbow Creek Site 2.

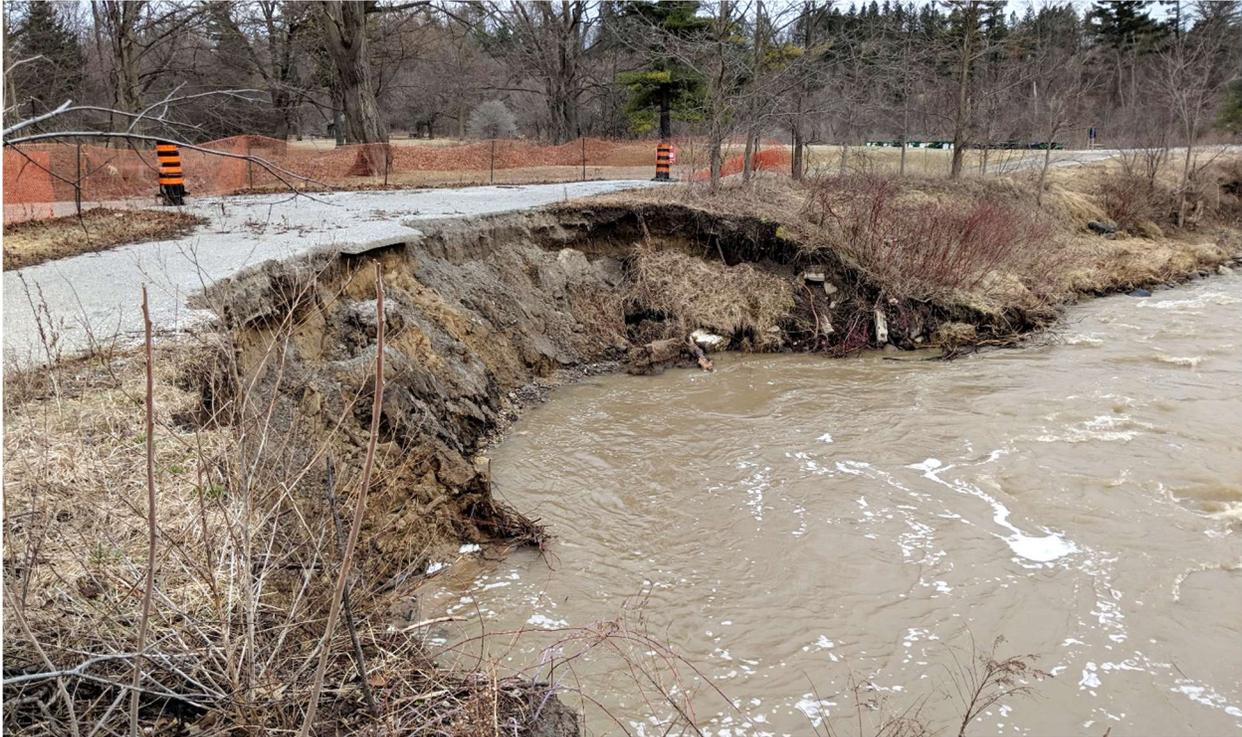
Figure 5. Eroding bank and trail in Boyd Conservation Area, City of Vaughan.

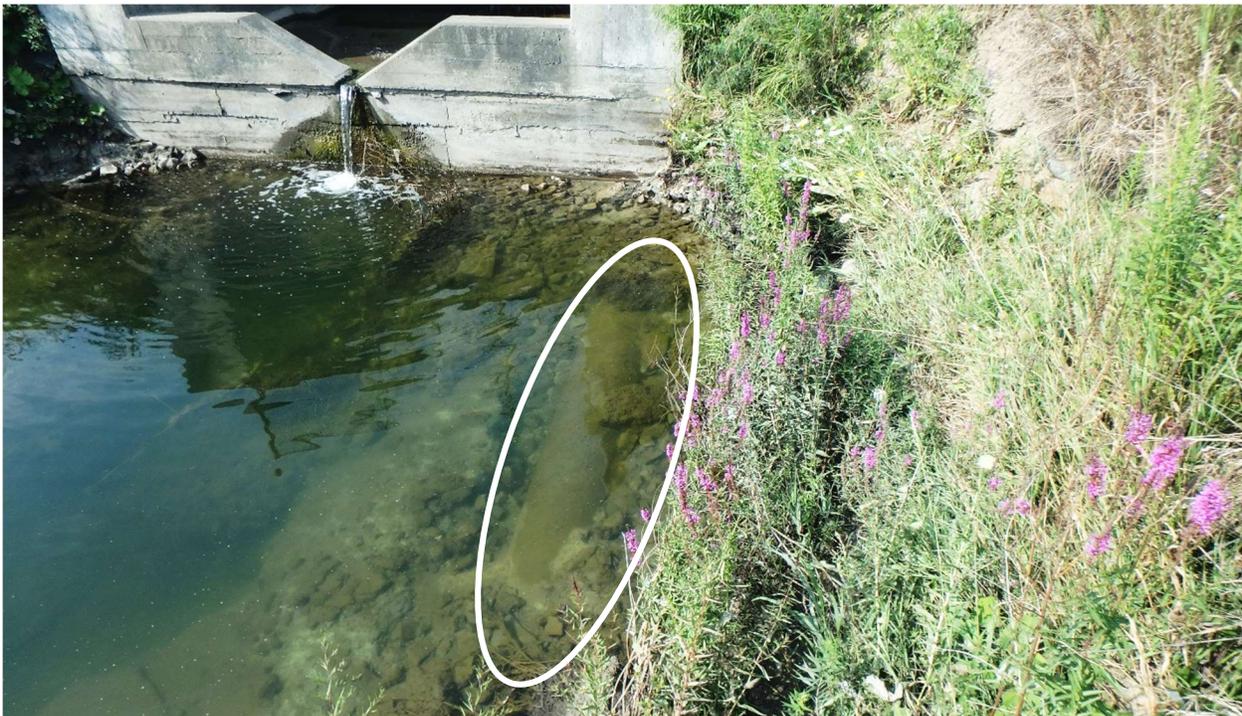
Figure 6. Exposed sanitary sewer (circled) at Region of Peel Infrastructure Site P-315.

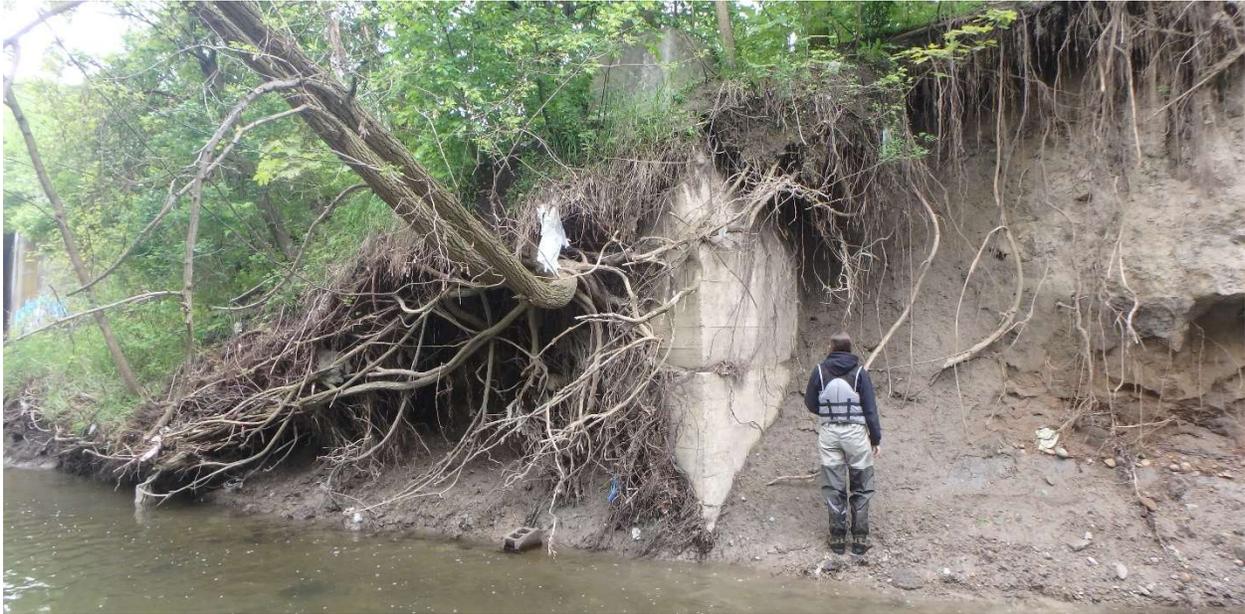
Figure 7. Exposed manhole chamber along Black Creek, City of Toronto.

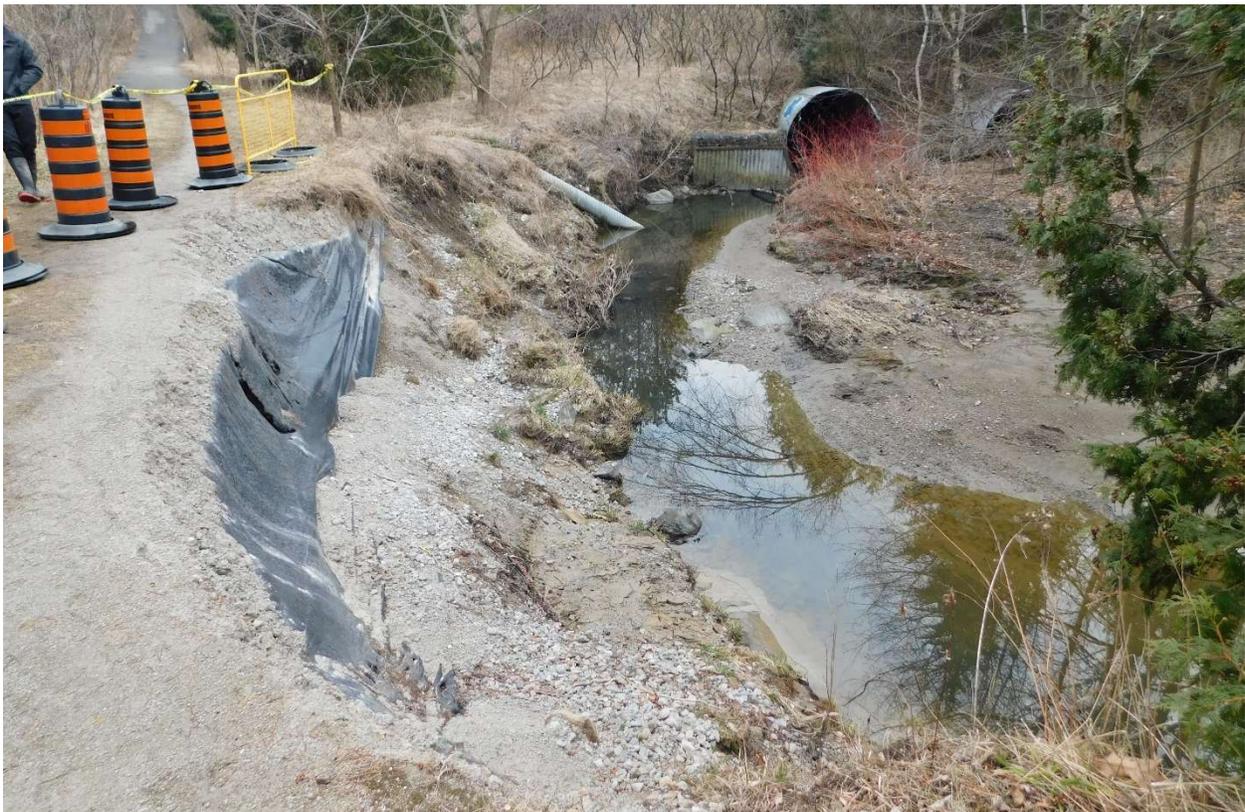
Figure 8. Eroding bank and trail along Newtonbrook Creek, City of Toronto.

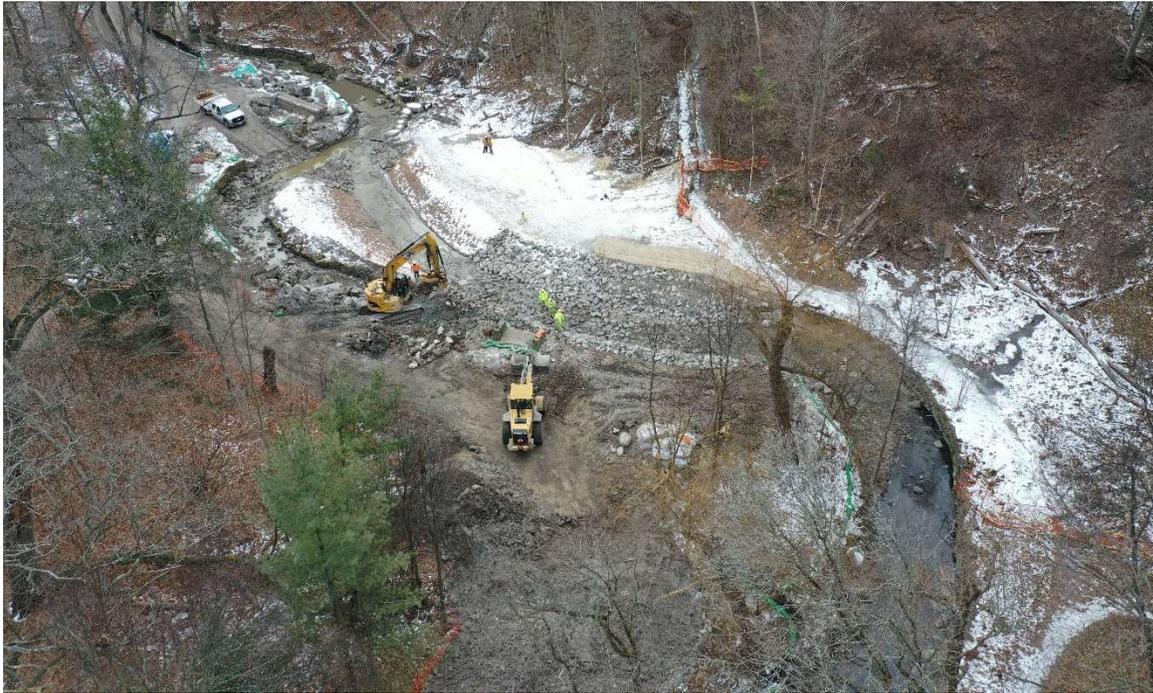
Figure 9. Active construction at the Yellow Creek Emergency Works Site, City of Toronto.

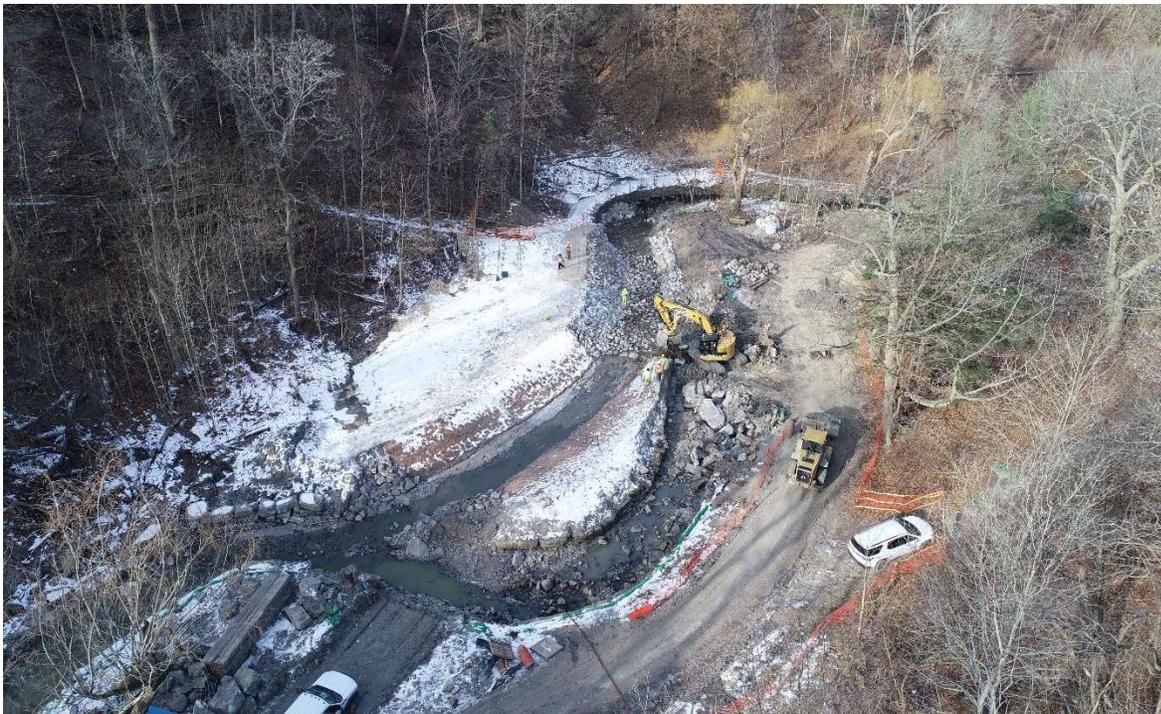
Figure 10. Active construction at the Yellow Creek Emergency Works Site, City of Toronto.
