ATTACHMENT 3
SITE PHOTOGRAPHS – EXISTING CONDITIONS

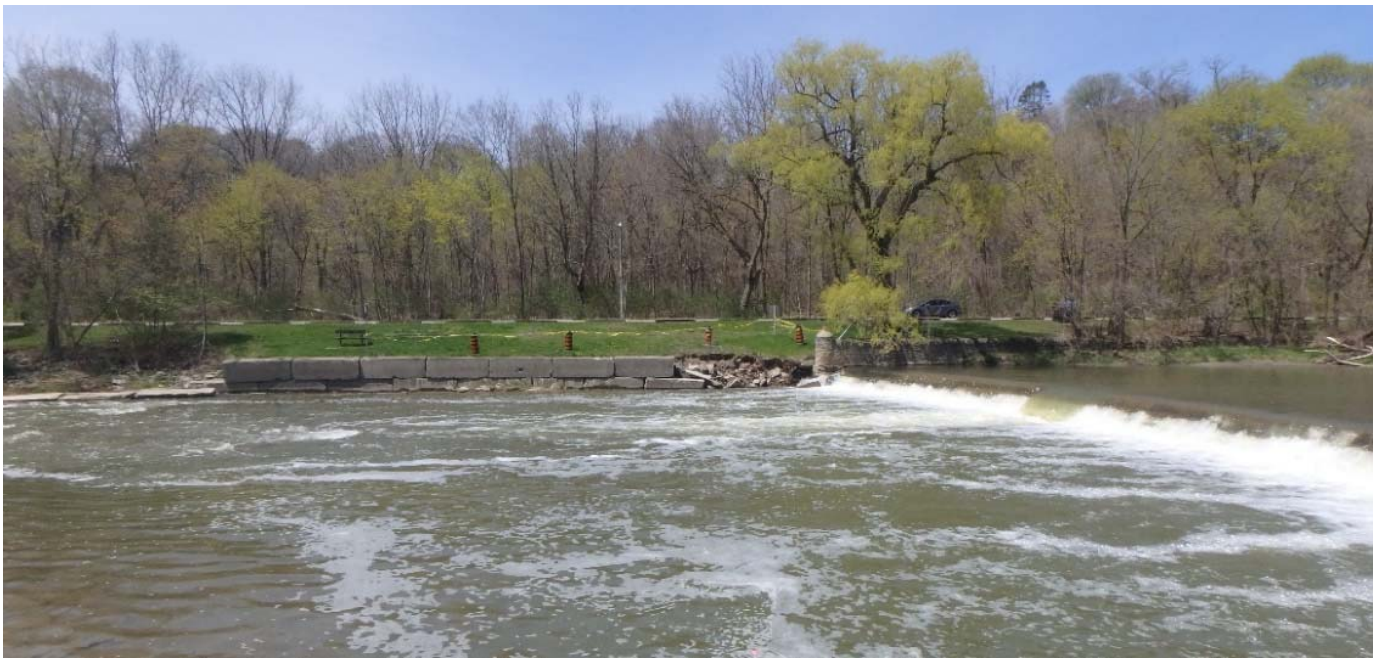
Photograph 1: View of the existing concrete block retaining wall and bank scour along the west bank.

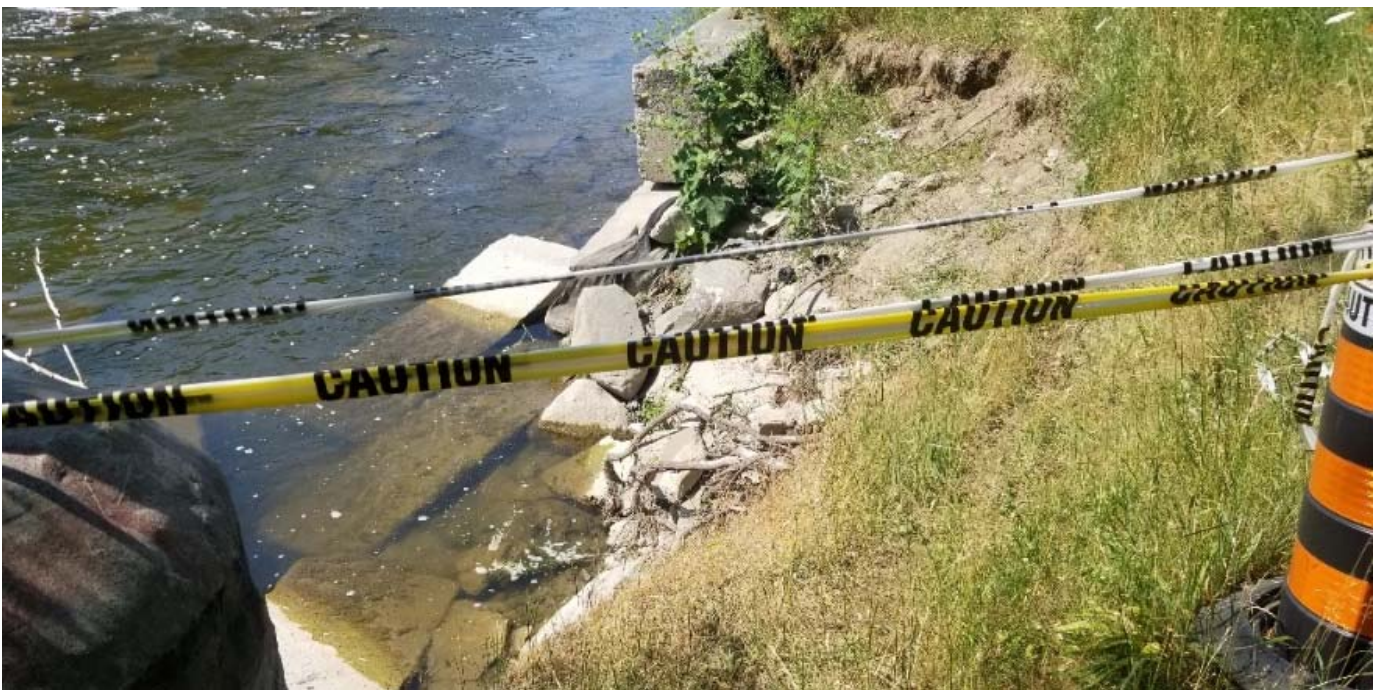
Photograph 2: View of displaced concrete blocks of the retaining wall at the location of the bank scour.
