Attachment 4: Photographs of various TRCA flood infrastructure and projects

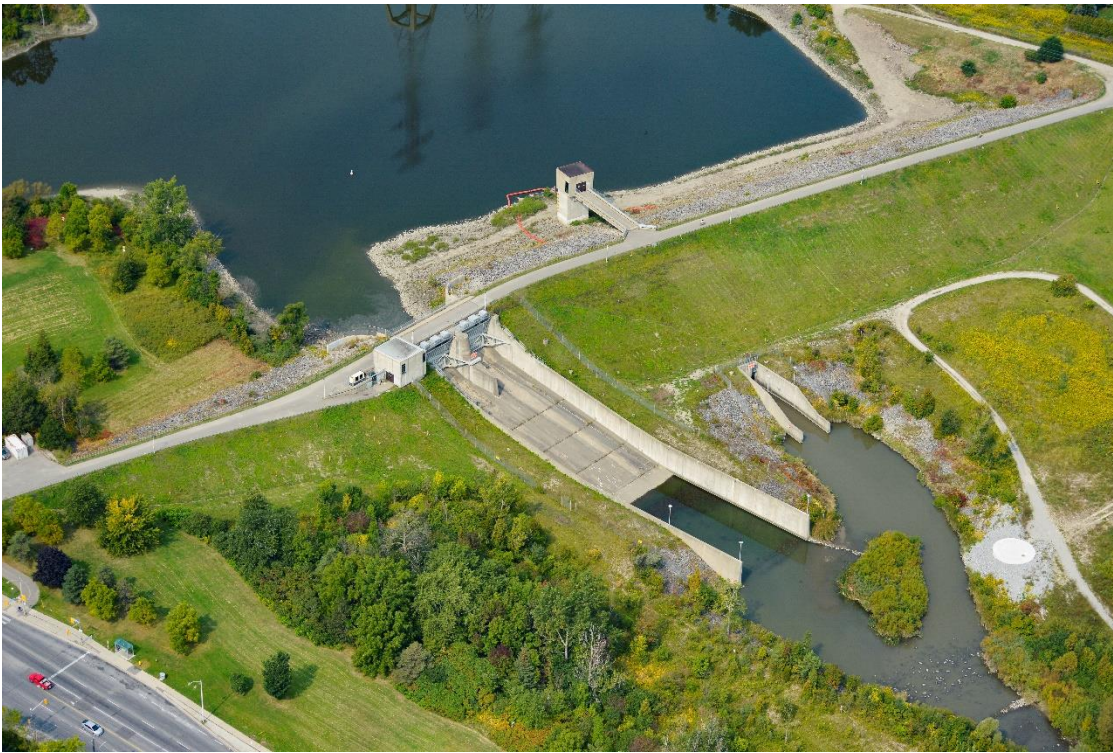
Figure 1 G. Ross Lord Dam carries the highest potential risk of any TRCA dam based on risk to life and property.

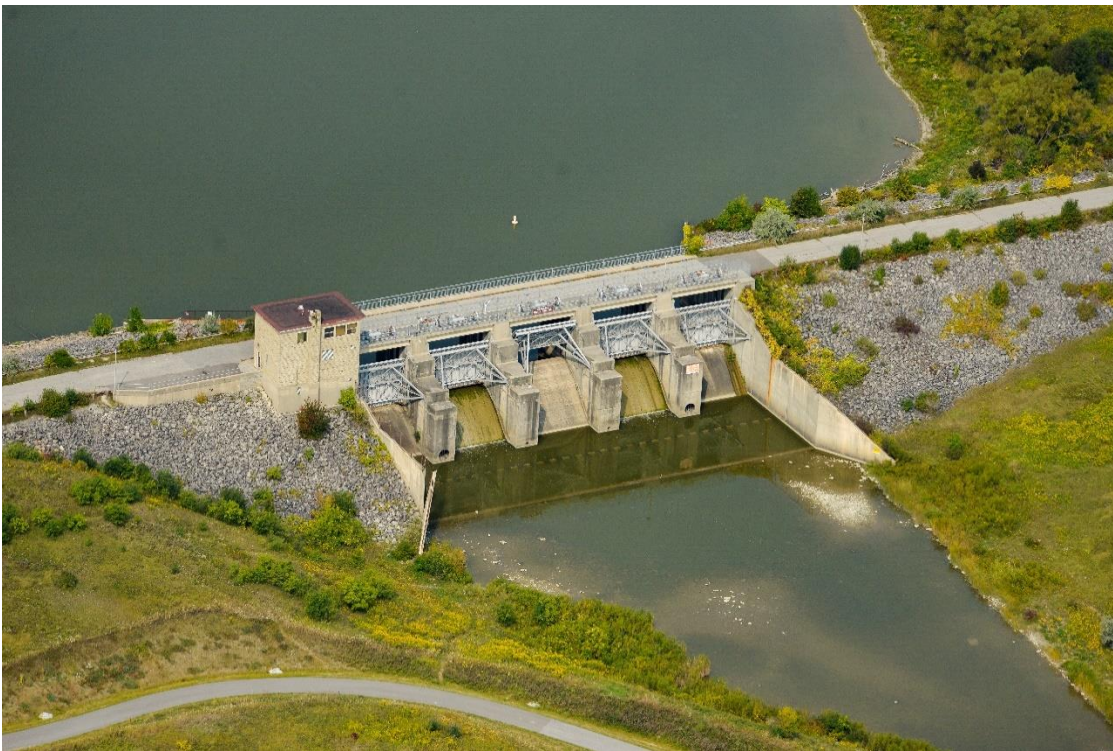
Figure 2 Claireville Dam was constructed in 1963 and requires major maintenance to meet current dam safety guidelines.

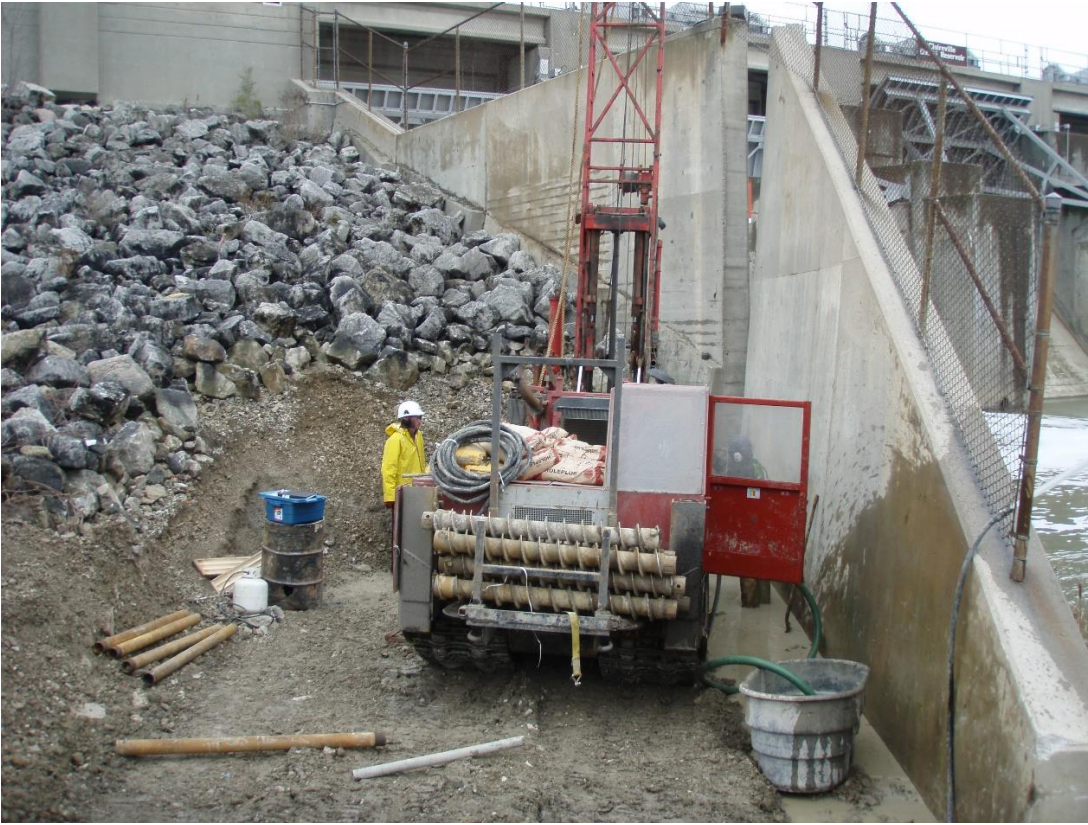
Figure 3 Claireville Dam wing wall settlement investigation.

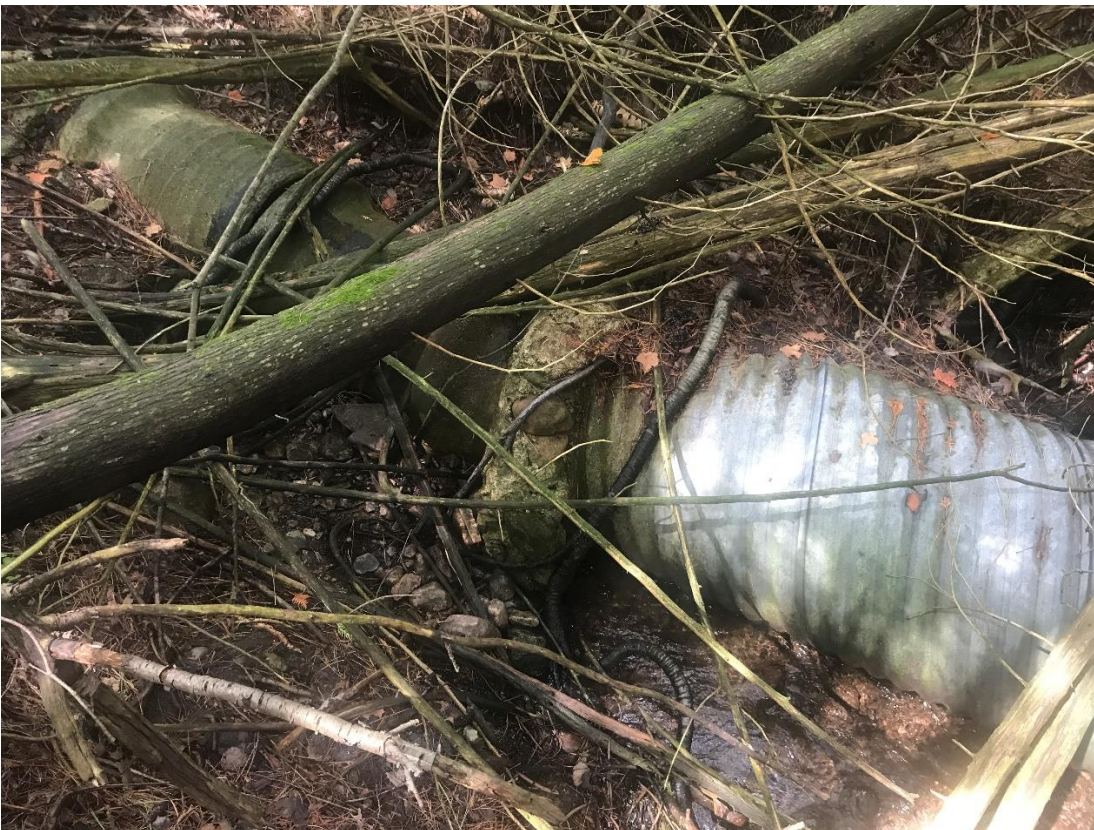
Figure 4 Failed spillway pipe at Glen Haffy Fly Fishing Upper Dam

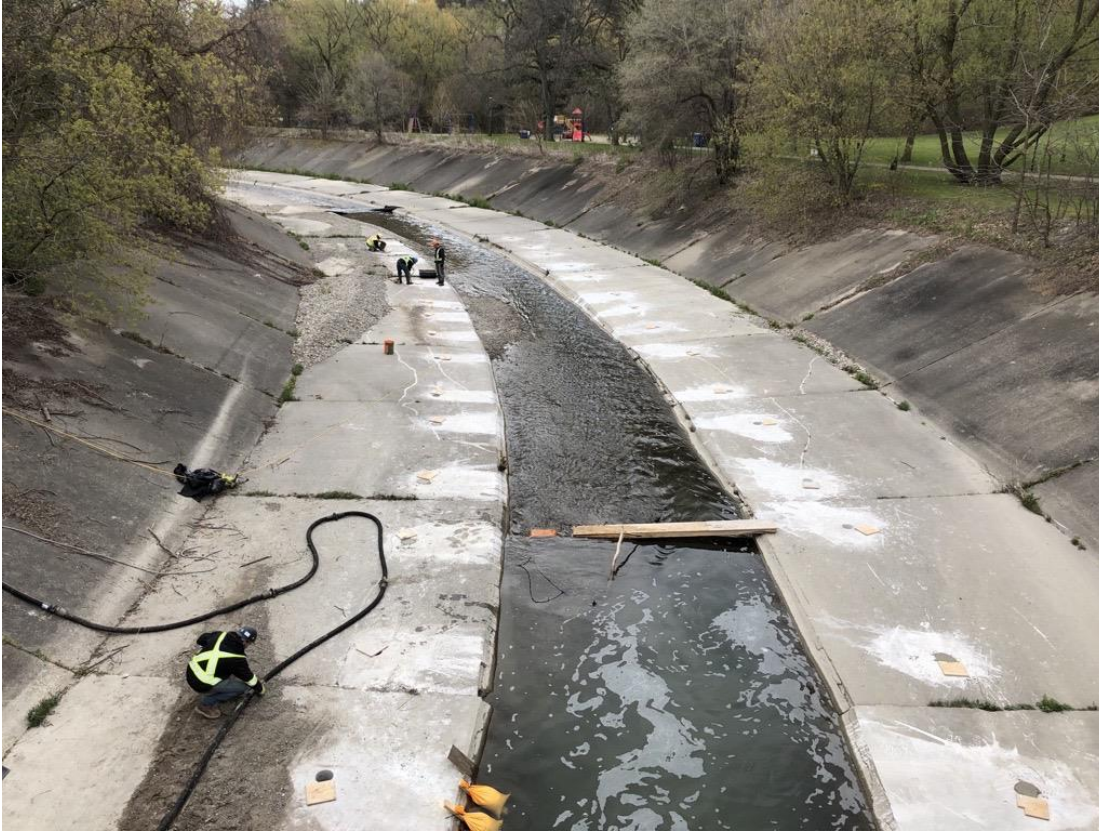
Figure 5 Yonge/York Mills Channel concrete repair in 2020.

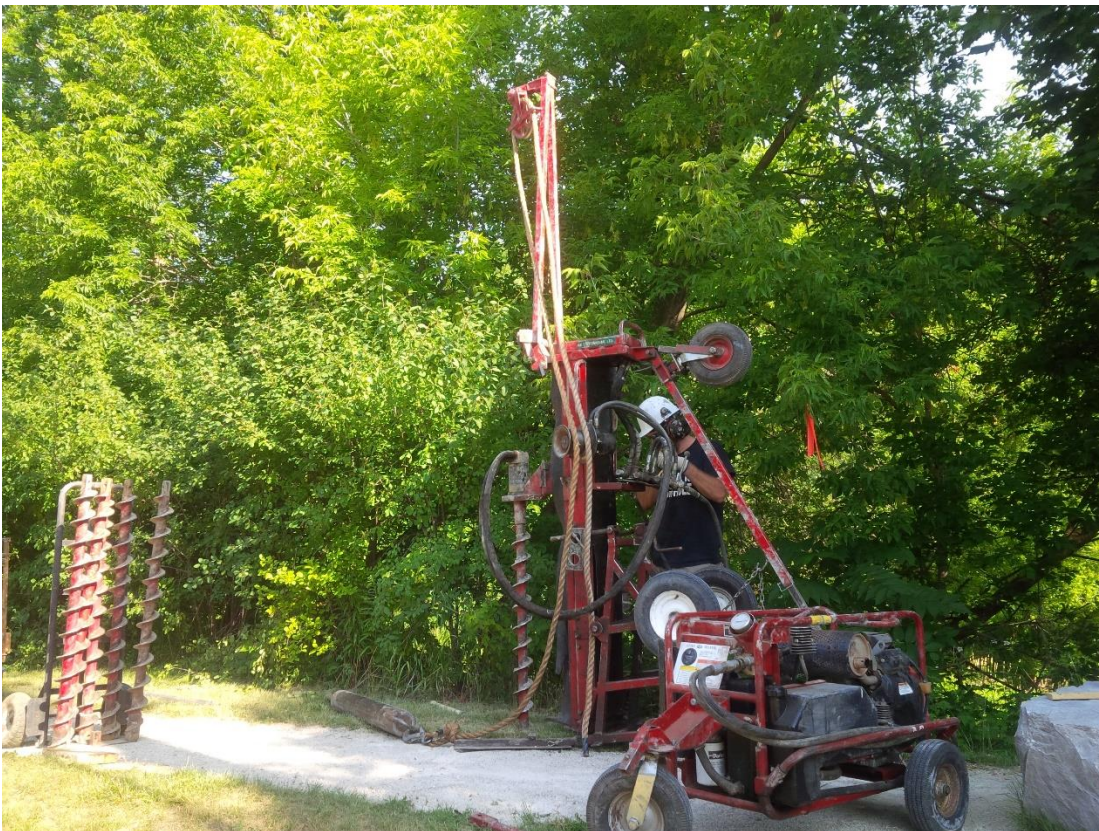
Figure 6 Bolton Berm 2016 geotechnical investigation.

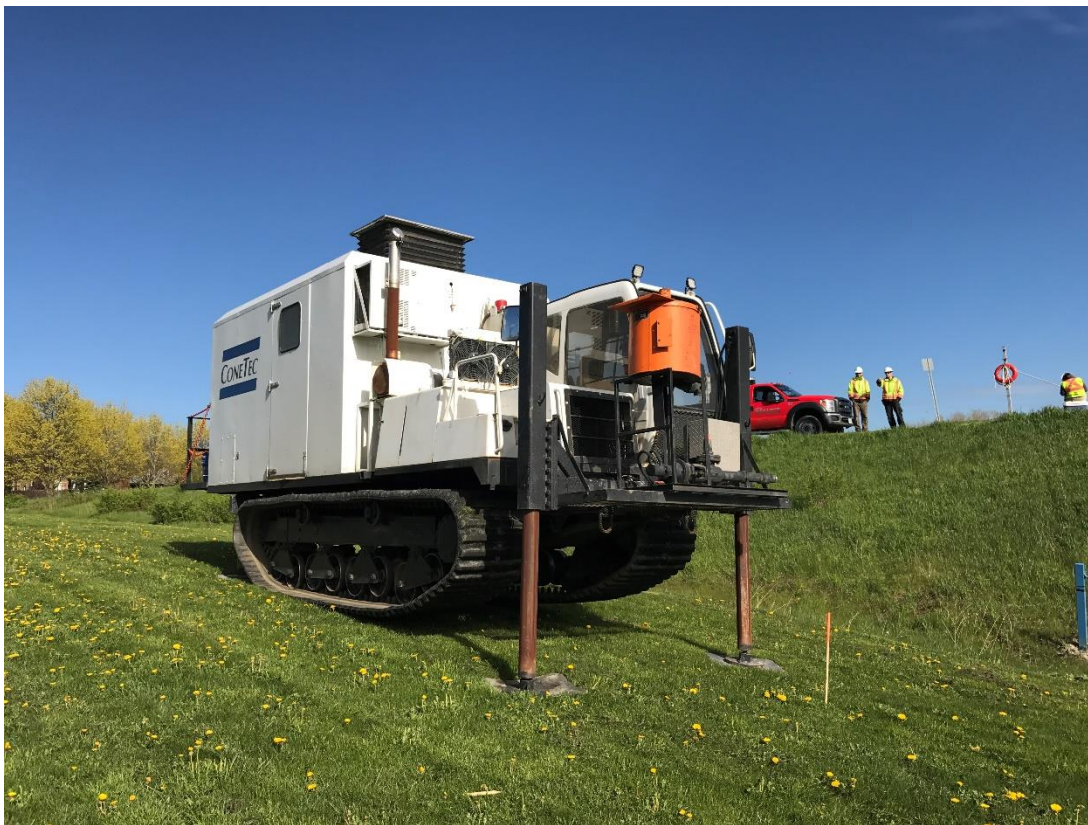
Figure 7 Stouffville Dam undergoing earthquake liquefaction investigation.

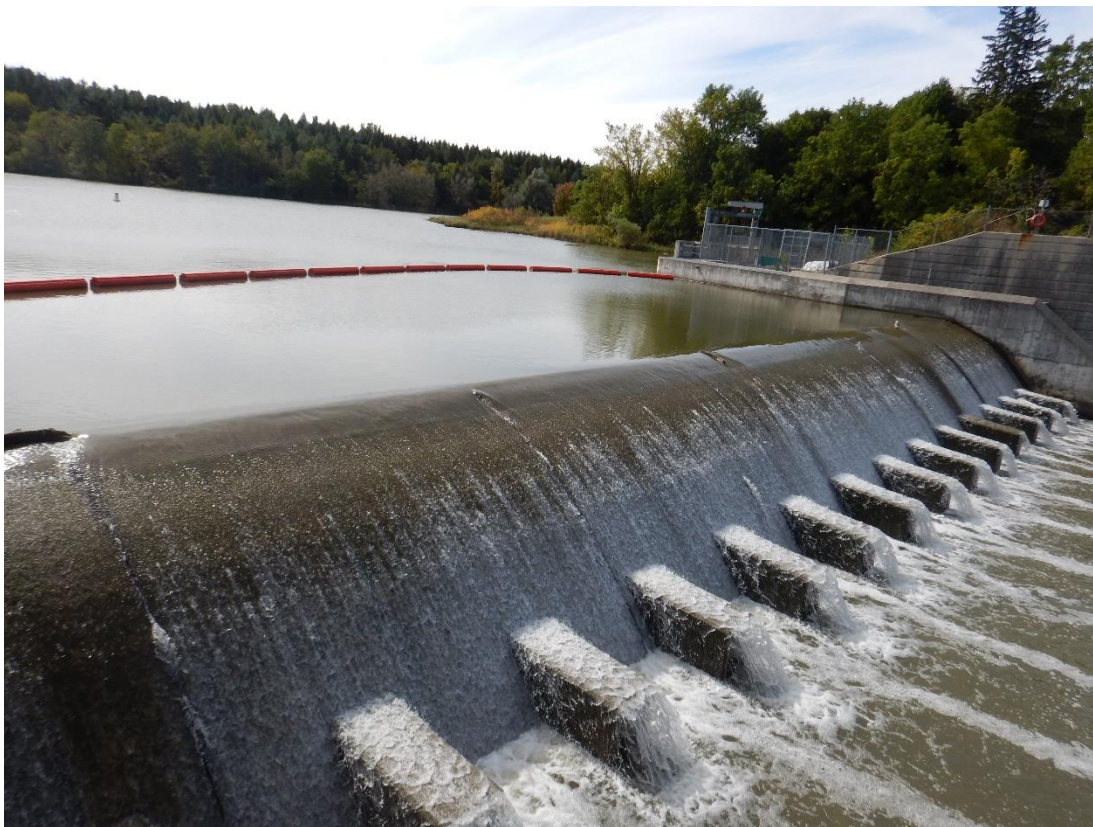
Figure 9 Milne Dam's spillway is too small for extreme floods and requires upgrades to withstand overtopping.

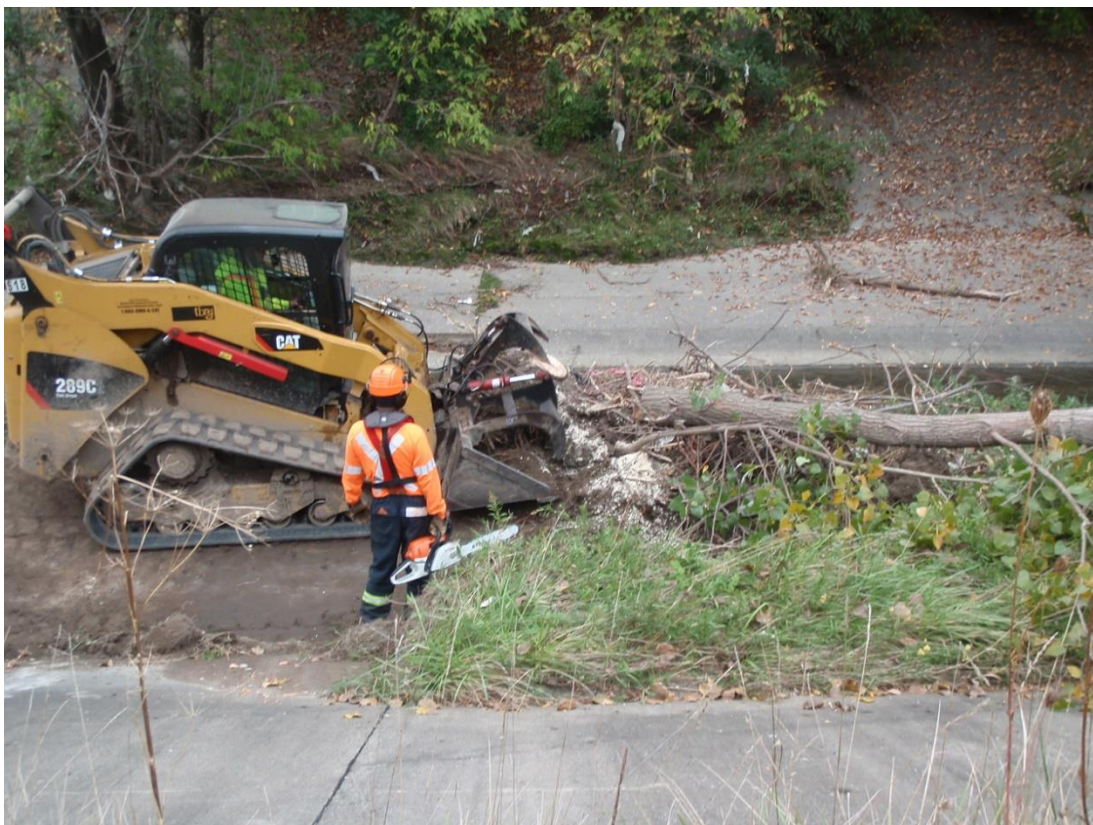
Figure 10 Black Creek Flood Control Channel undergoing major maintenance to restore conveyance.

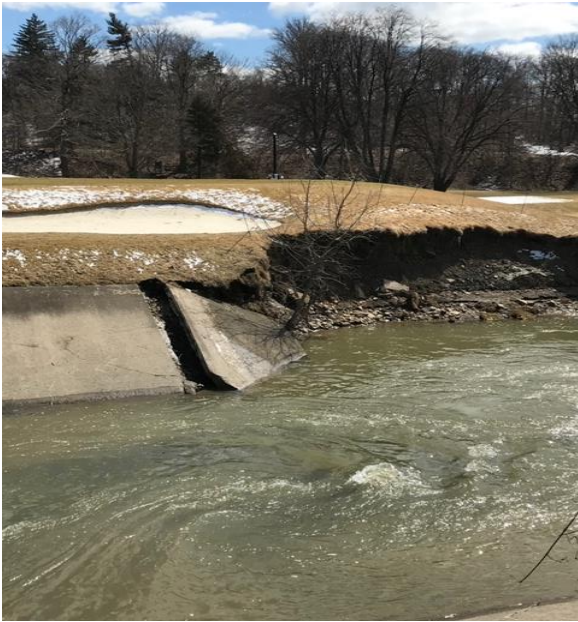
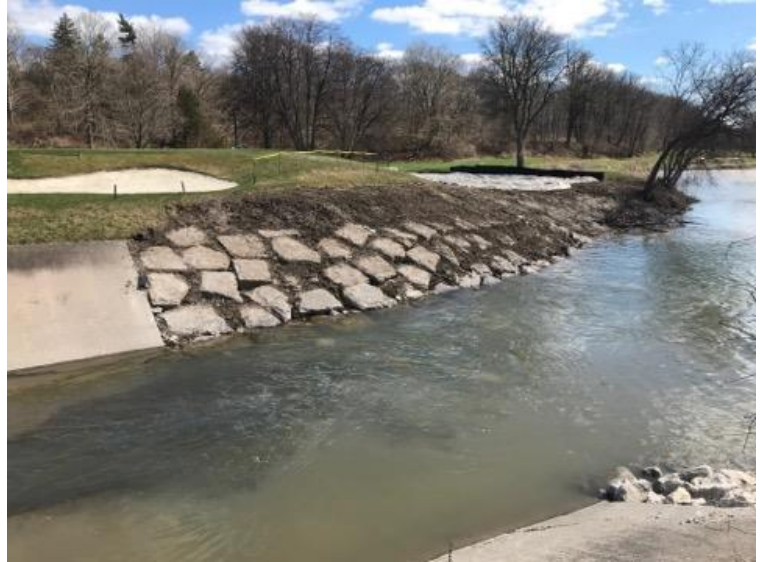
Figure 11 Scarlett Flood Control Channel erosion repair before and after photos.

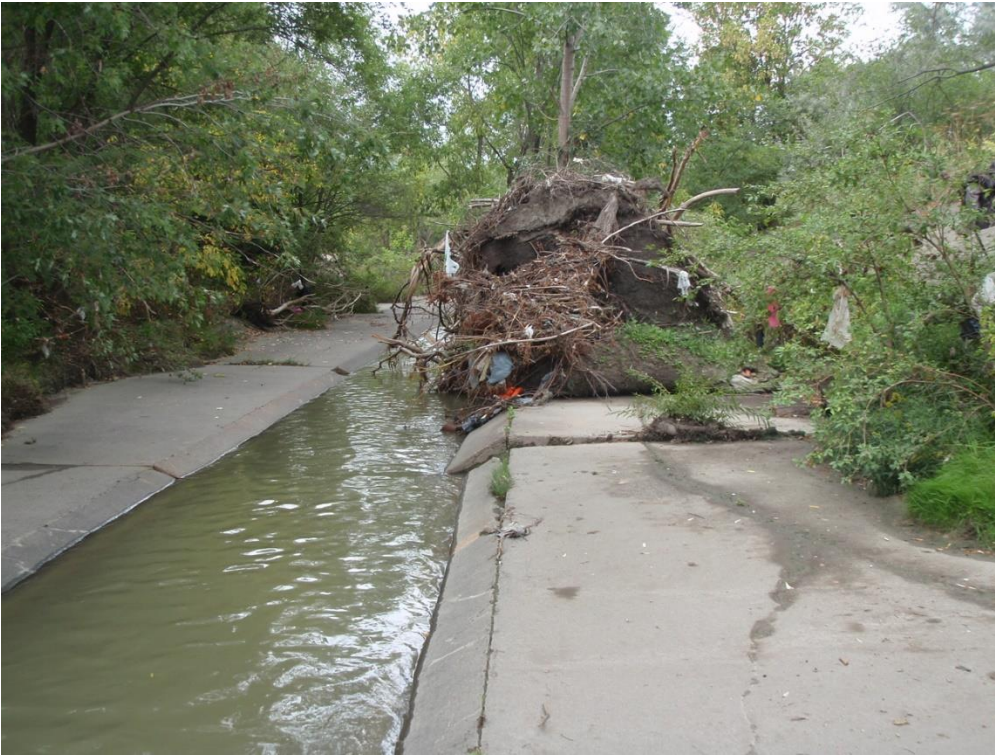
Figure 13 Partially blocked flood control channel at Black Creek.

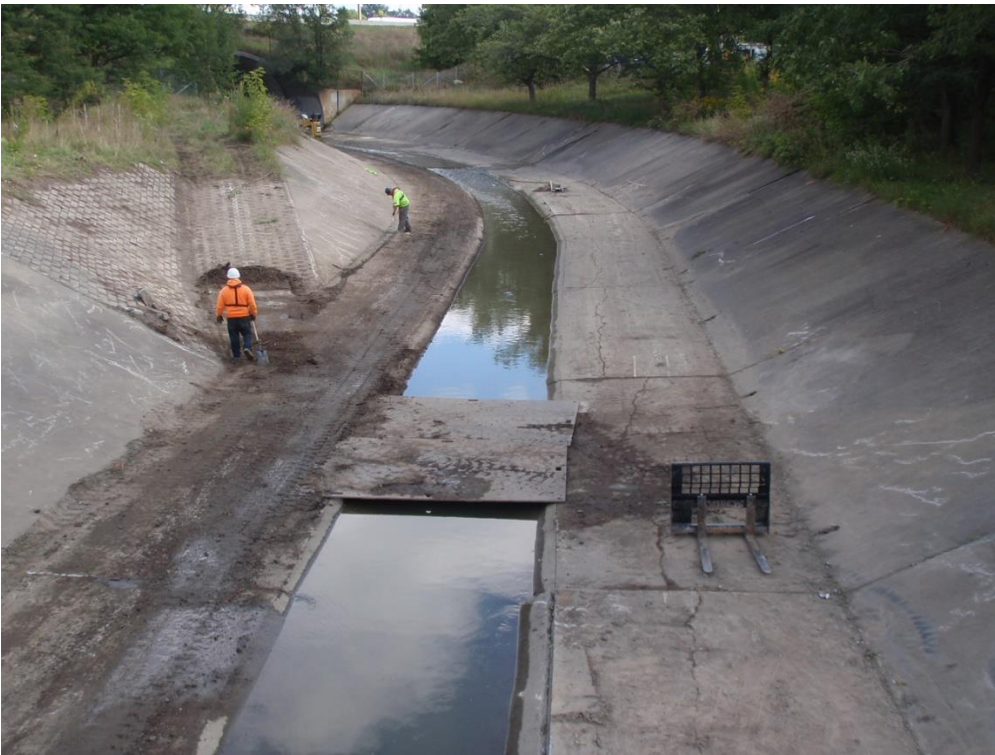
Figure 14 Black Creek Channel after major maintenance (2014).

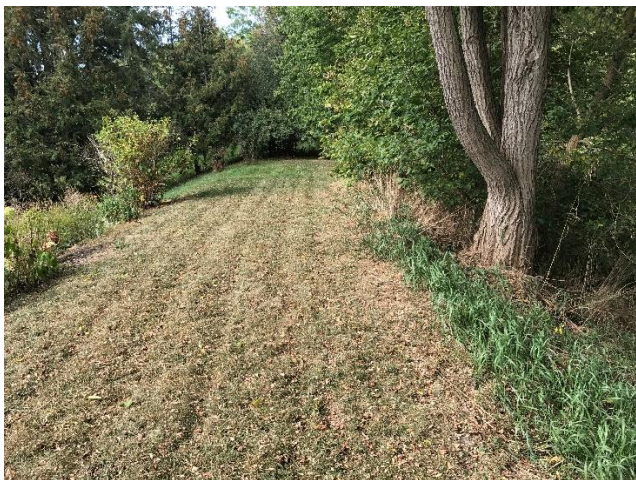
Figure 15 Bolton Berm before major maintenance and upgrades.

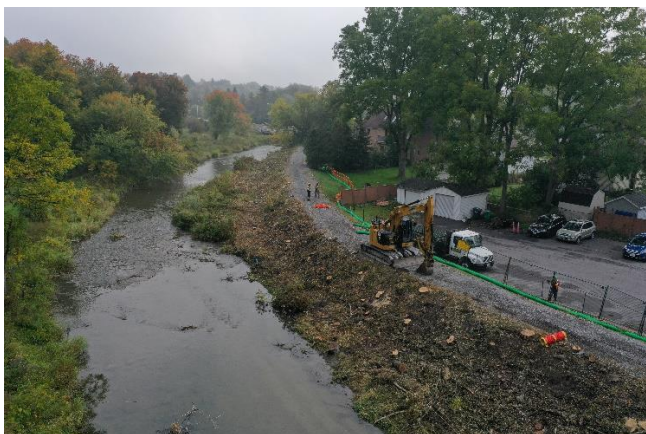
Figure 16 Bolton Berm repair as seen from drone survey (2020).

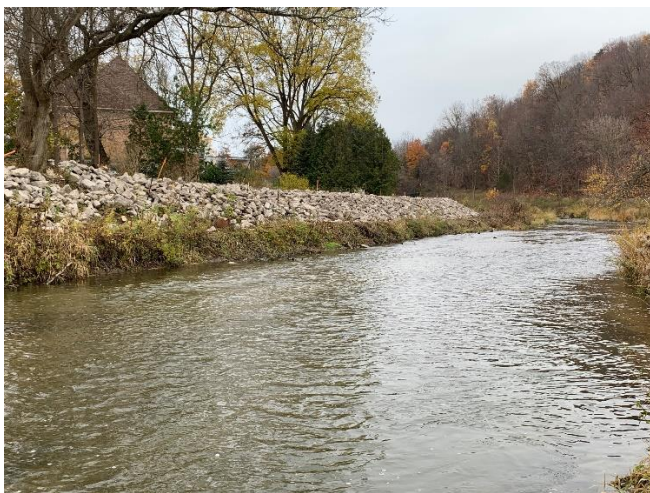
Figure 17 Bolton Berm rip rap installation (2020).
