Aging Assets at Petticoat Creek CP

Need for Coordinated Funding Support from All Levels of Government

Attachment 1 – Board of Directors Report

April 30, 2021

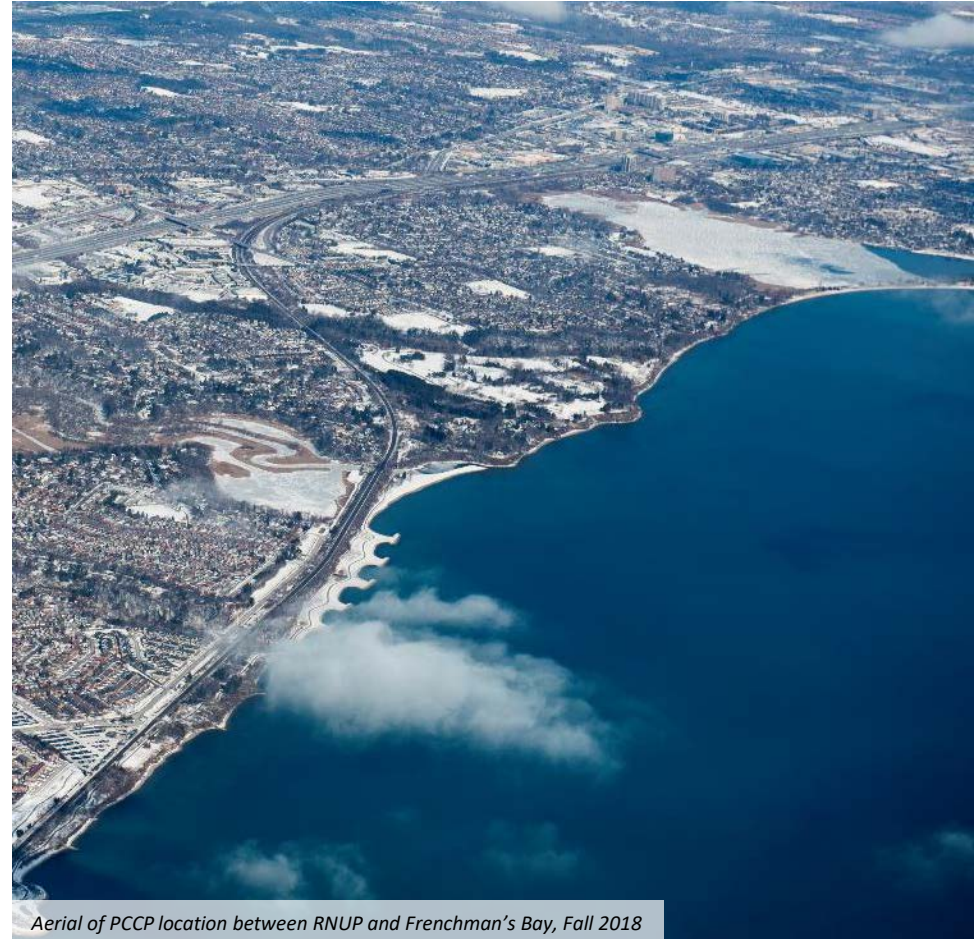
Aerial of PCCP location between RNUP and Frenchman's Bay, Fall 2018

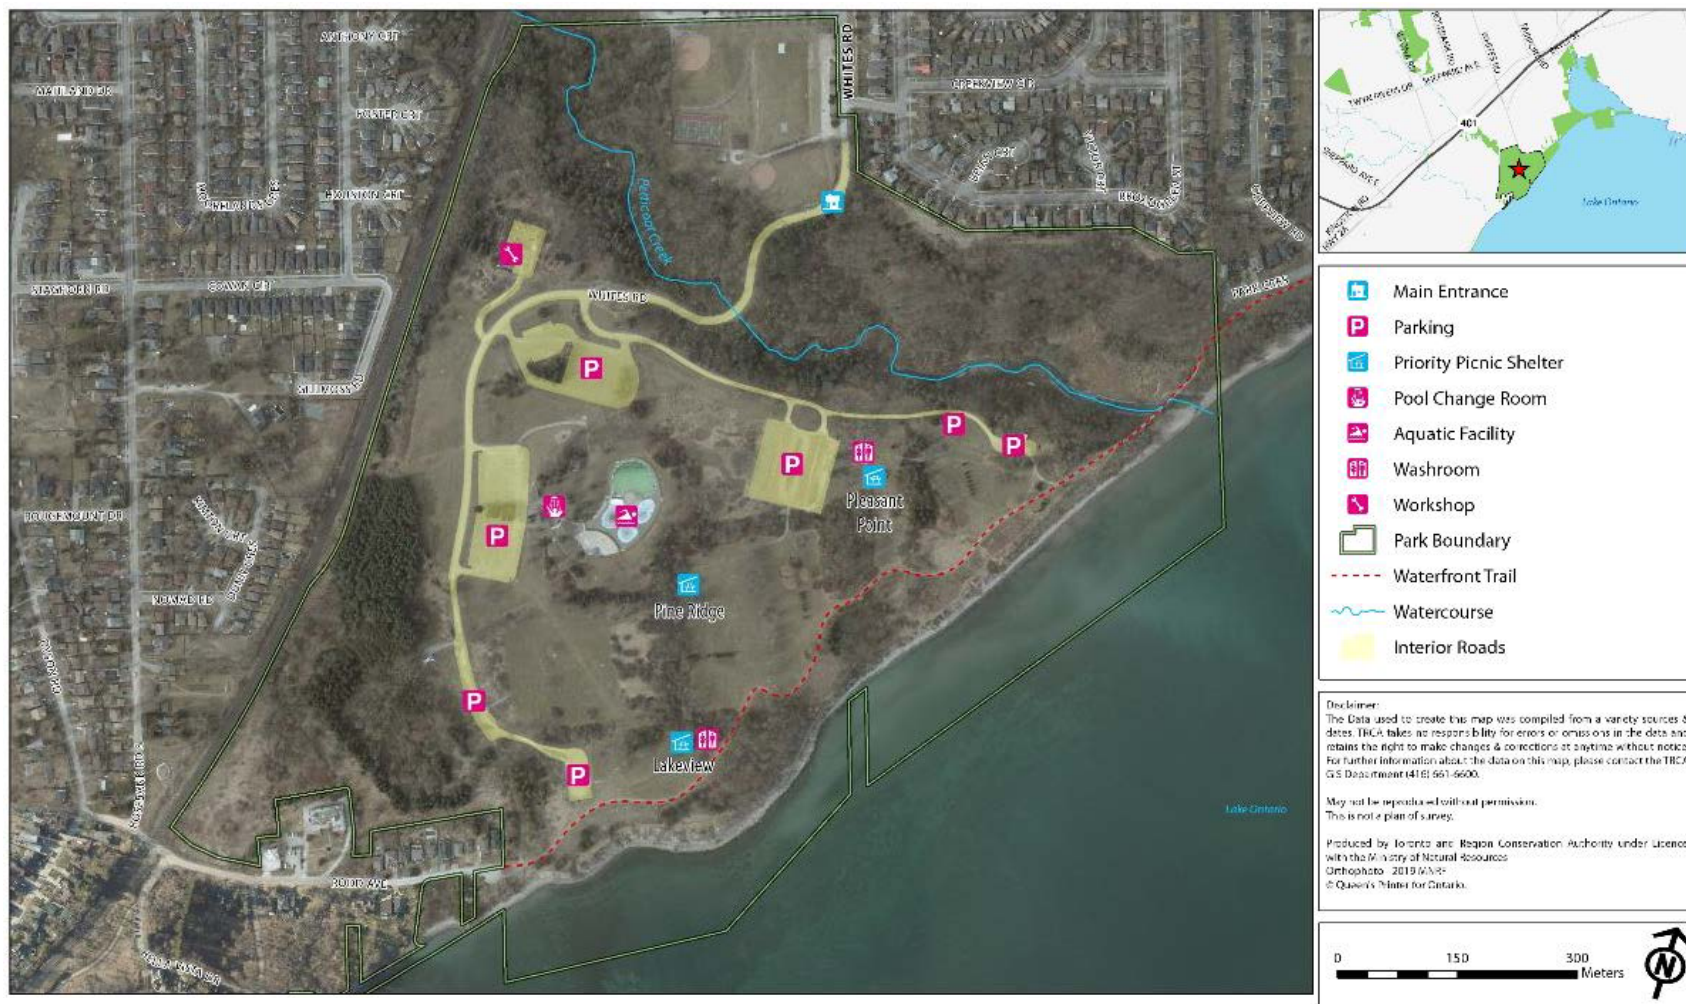
Park Map – Pressing Issues

- The following are several pressing issues that will require funding in the immediate future:
 - Park Driveway Entrance
 - Aquatic facility
 - Picnic Shelters
 - Washrooms
 - Automated Gates
 - Parking Lots
 - Additional Park Concerns (Sewers, Sink Holes, Bluff Erosion)
 - Recent and Planned Infrastructure Upgrades (Workshop)
 - Summary

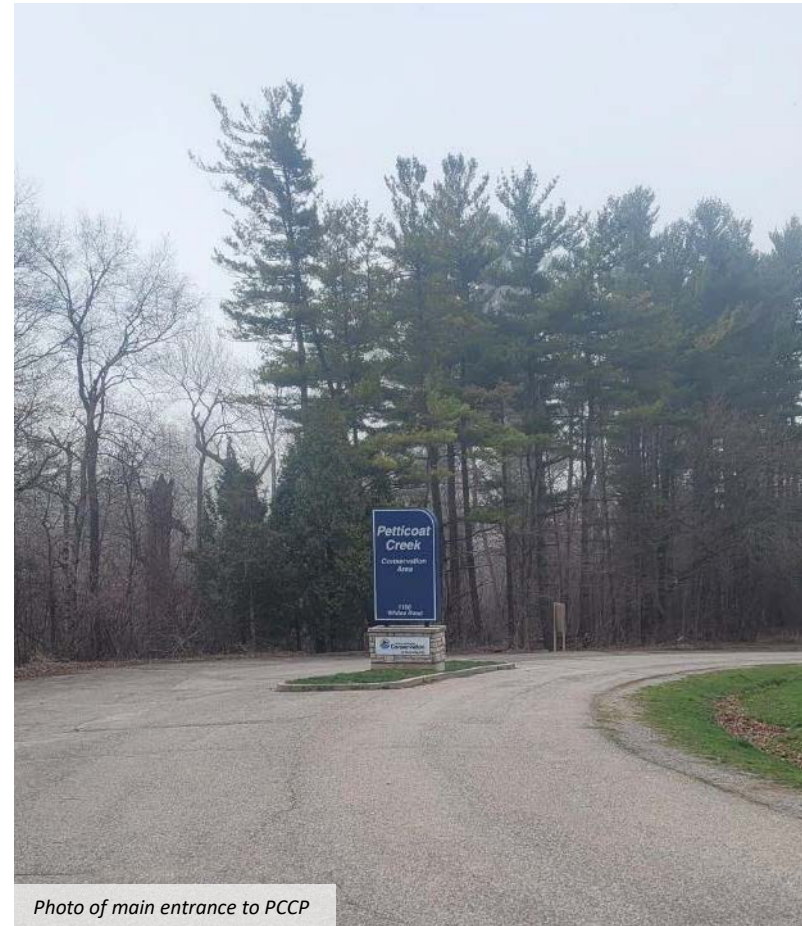
Photo of main entrance to PCCP

- Requires major reconstruction and expansion
- Existing condition of the roadway results in conflicted use
- Safety concerns due to potential incidents between both vehicles, pedestrians and cyclists
- Incorporate a formal pedestrian sidewalk which is not part of the existing driveway and will strive to meet AODA requirements
- Additional assessments required to investigate the storm water management

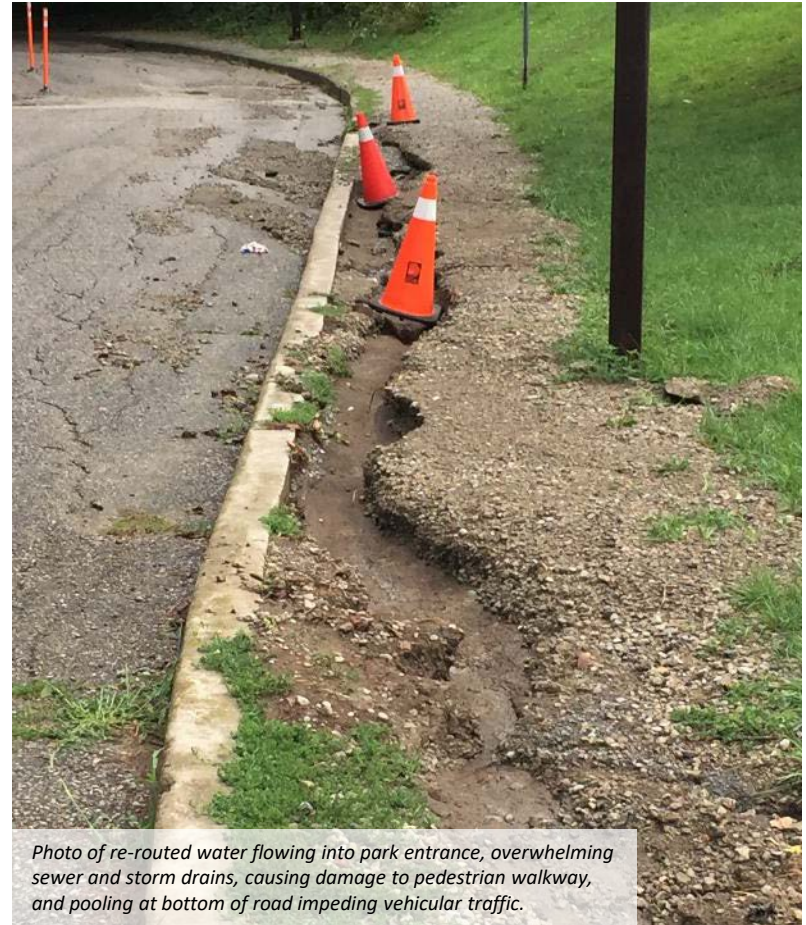
- Surface water re-routed from Dunmoore Park into PCCP overwhelming sewer and storm drains, causing property damage that is compromising the park entrance

Photo of re-routed water flowing into park entrance, overwhelming sewer and storm drains, causing damage to pedestrian walkway, and pooling at bottom of road impeding vehicular traffic.

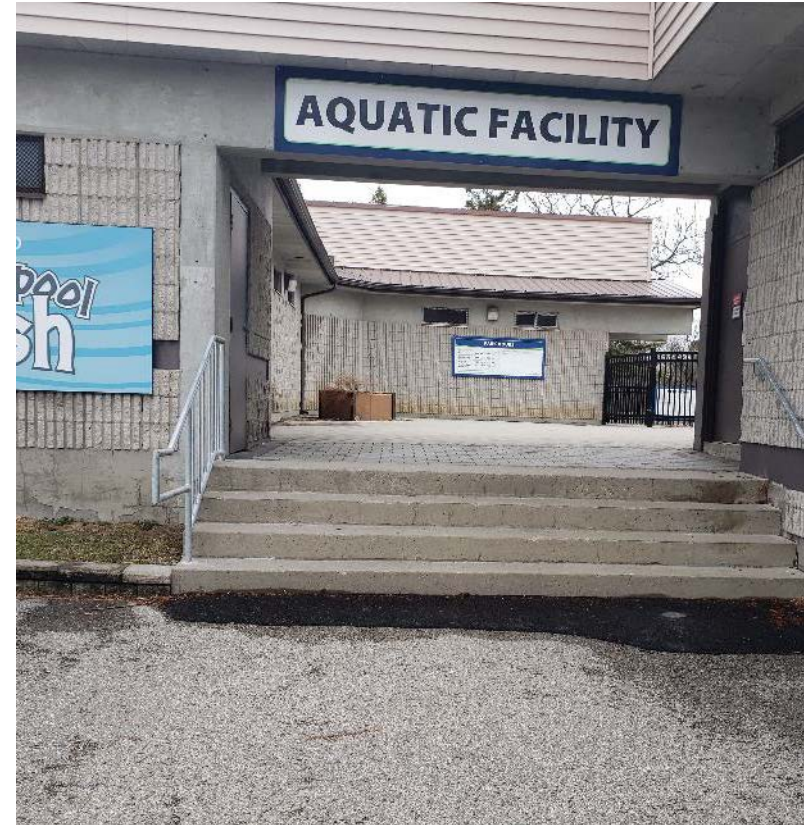
- Significant defects identified in construction and aquatic system
- Preliminary reviews by external consultant indicating that pool infrastructure is end of life and not meeting many current regulations. Further recommendations to be provided by external consultant
- Asphalt settling around concrete stairs; numerous plumbing issues; HVAC system nonfunctioning; asbestos tiles in ceiling; light fixtures need replacement

Photo of entrance to the Aquatic Facility. Asphalt settling around concrete stairs. Stairs are steep and narrow. Patch work completed at base of steps and railings installed in attempt to mitigate risk.

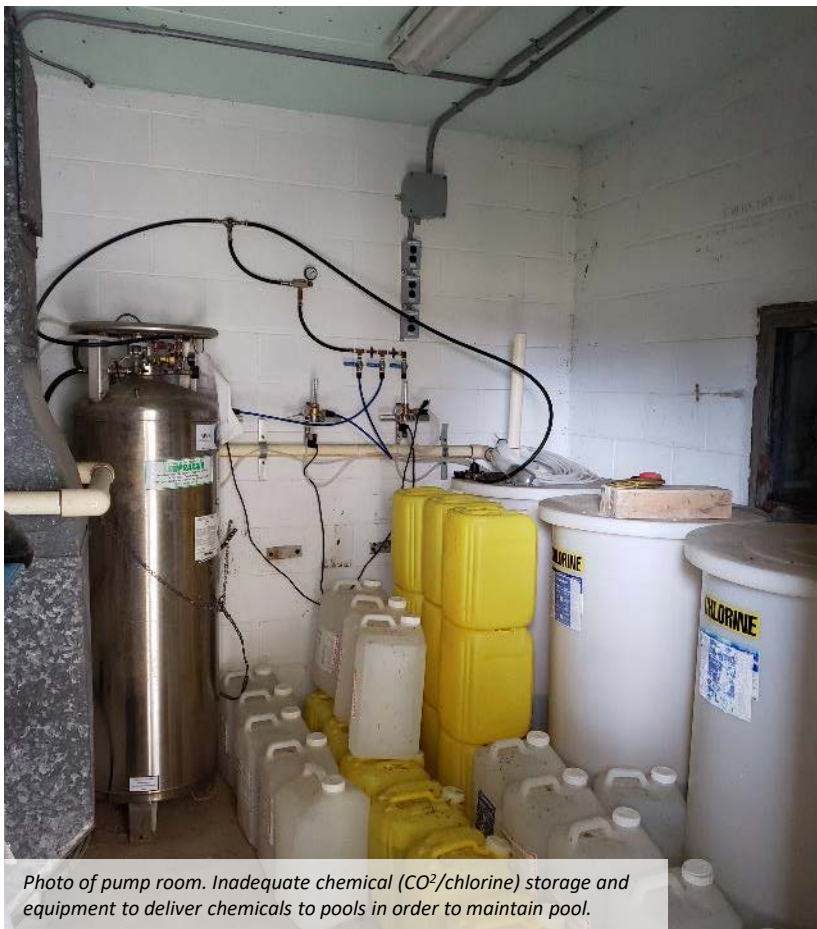
Photo of pump room. Inadequate chemical (CO_2 /chlorine) storage and equipment to deliver chemicals to pools in order to maintain pool.

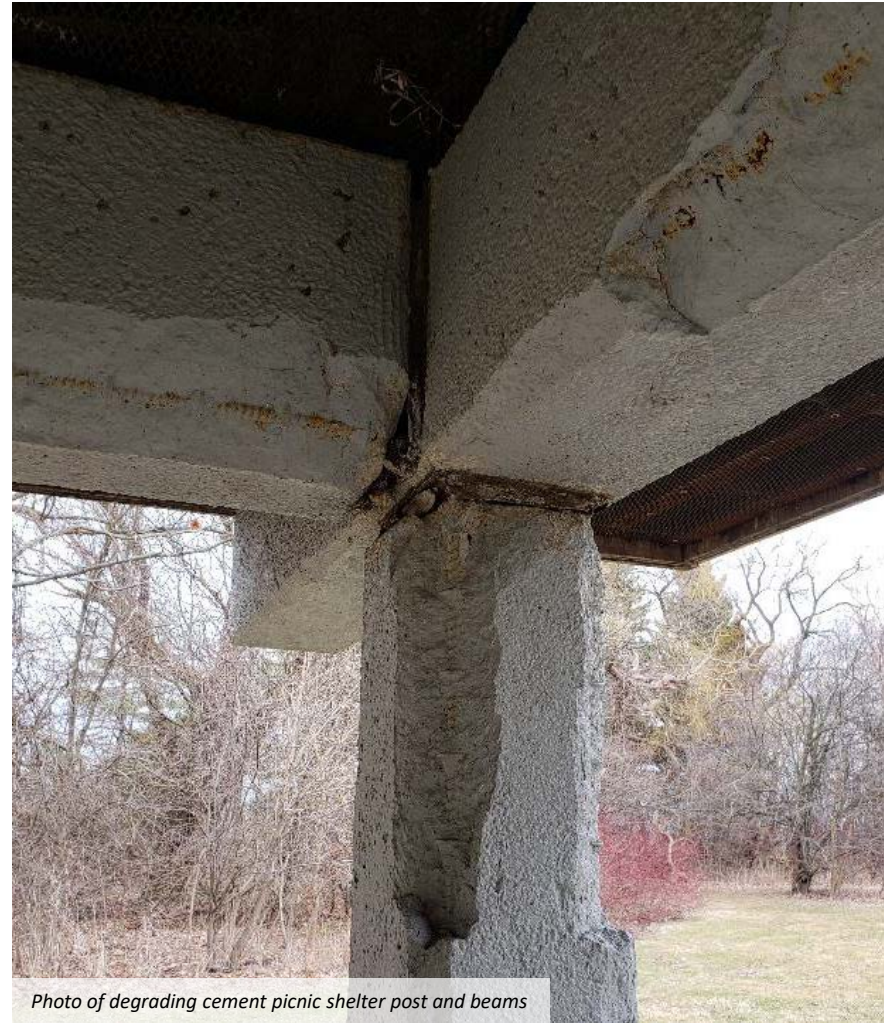
- Structural Integrity Issues:
 - Broken asbestos tile and ceiling supports; heaving patio stones due to tree roots; shelter located in drainage path – during heavy weather events can be 2-4 inches of water pooled on the floor; ceiling missing protective mesh; broken structure due to vandalism and aging
- Capacity Issue:
 - Additional picnic shelters required to support high visitation levels

Photo of degrading cement picnic shelter post and beams

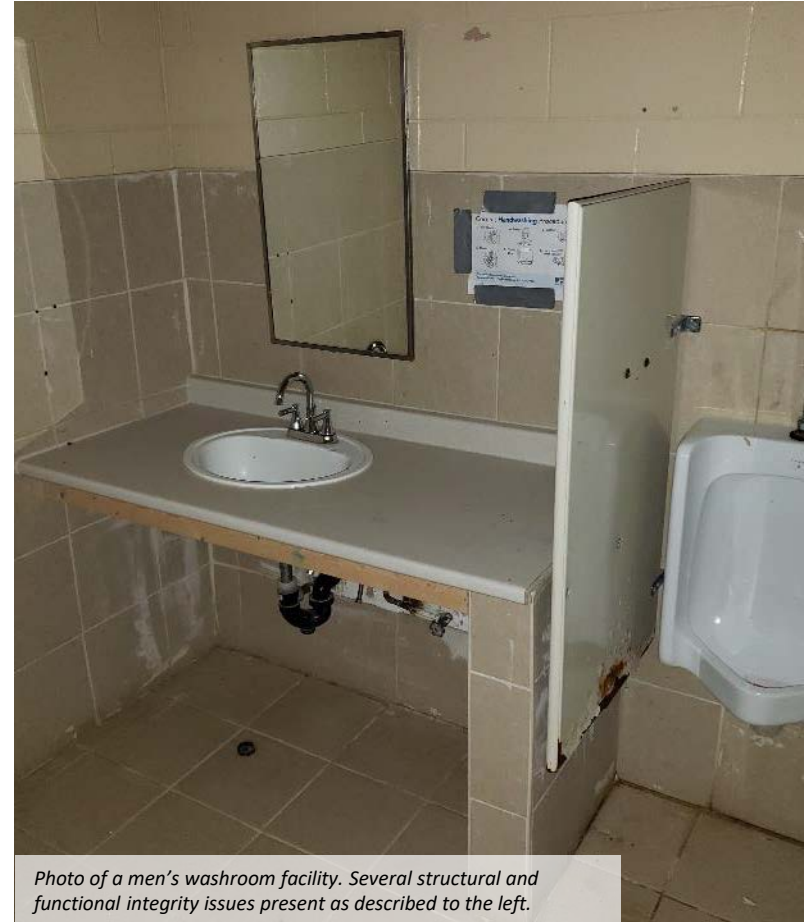
- Structural Integrity Issues:
 - Asbestos present; heaved concrete floor; compromised plumbing; no hot water or HVAC; broken and uneven tiles; poor and damaged lighting; partition's rotting; difficult activation buttons on sanitary plumbing
- Accessibility Issues:
 - Despite having accessible stalls and signage, entrance path concrete broken and uneven and wheelchairs cannot enter
- Capacity Issue:
 - Additional facilities required to support high visitation levels

Photo of a men's washroom facility. Several structural and functional integrity issues present as described to the left.

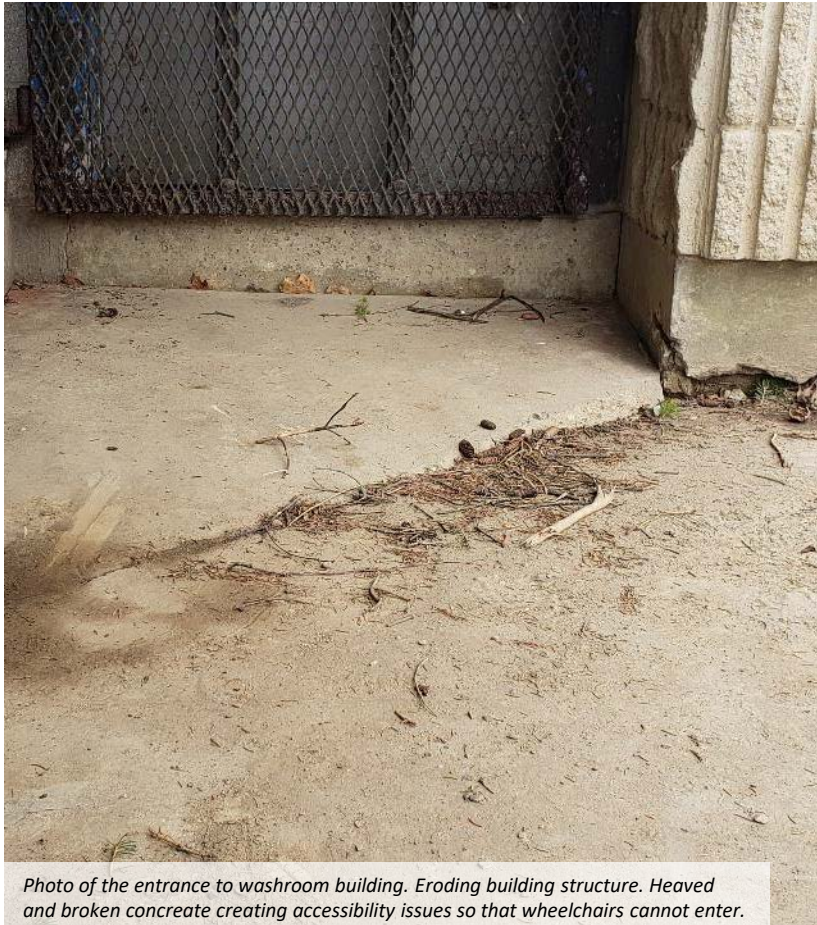
Photo of the entrance to washroom building. Eroding building structure. Heaved and broken concrete creating accessibility issues so that wheelchairs cannot enter.

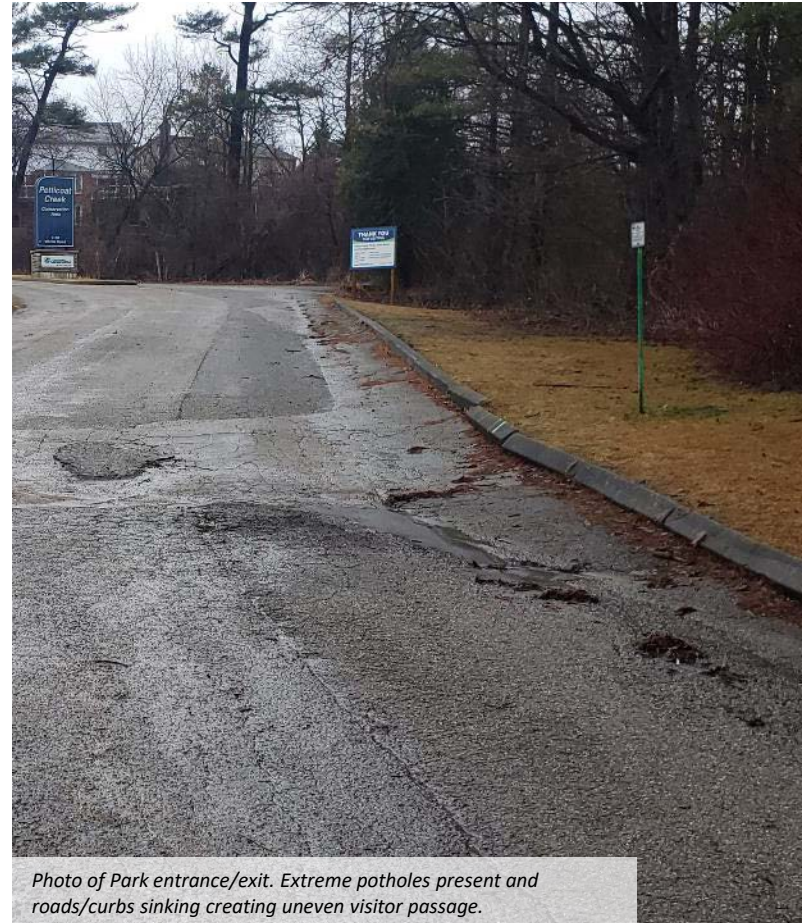
- Significant cracking, sinking, and uneven with significant heaving in roads and curbs
- Shared entrance between pedestrians, vehicles, and bikes has become extremely dangerous
- Parking lots require reconstruction due to potholes and restricted capacity. The current conditions result in safety concerns within the parking lot, as well as beyond.

Photo of Park entrance/exit. Extreme potholes present and roads/curbs sinking creating uneven visitor passage.

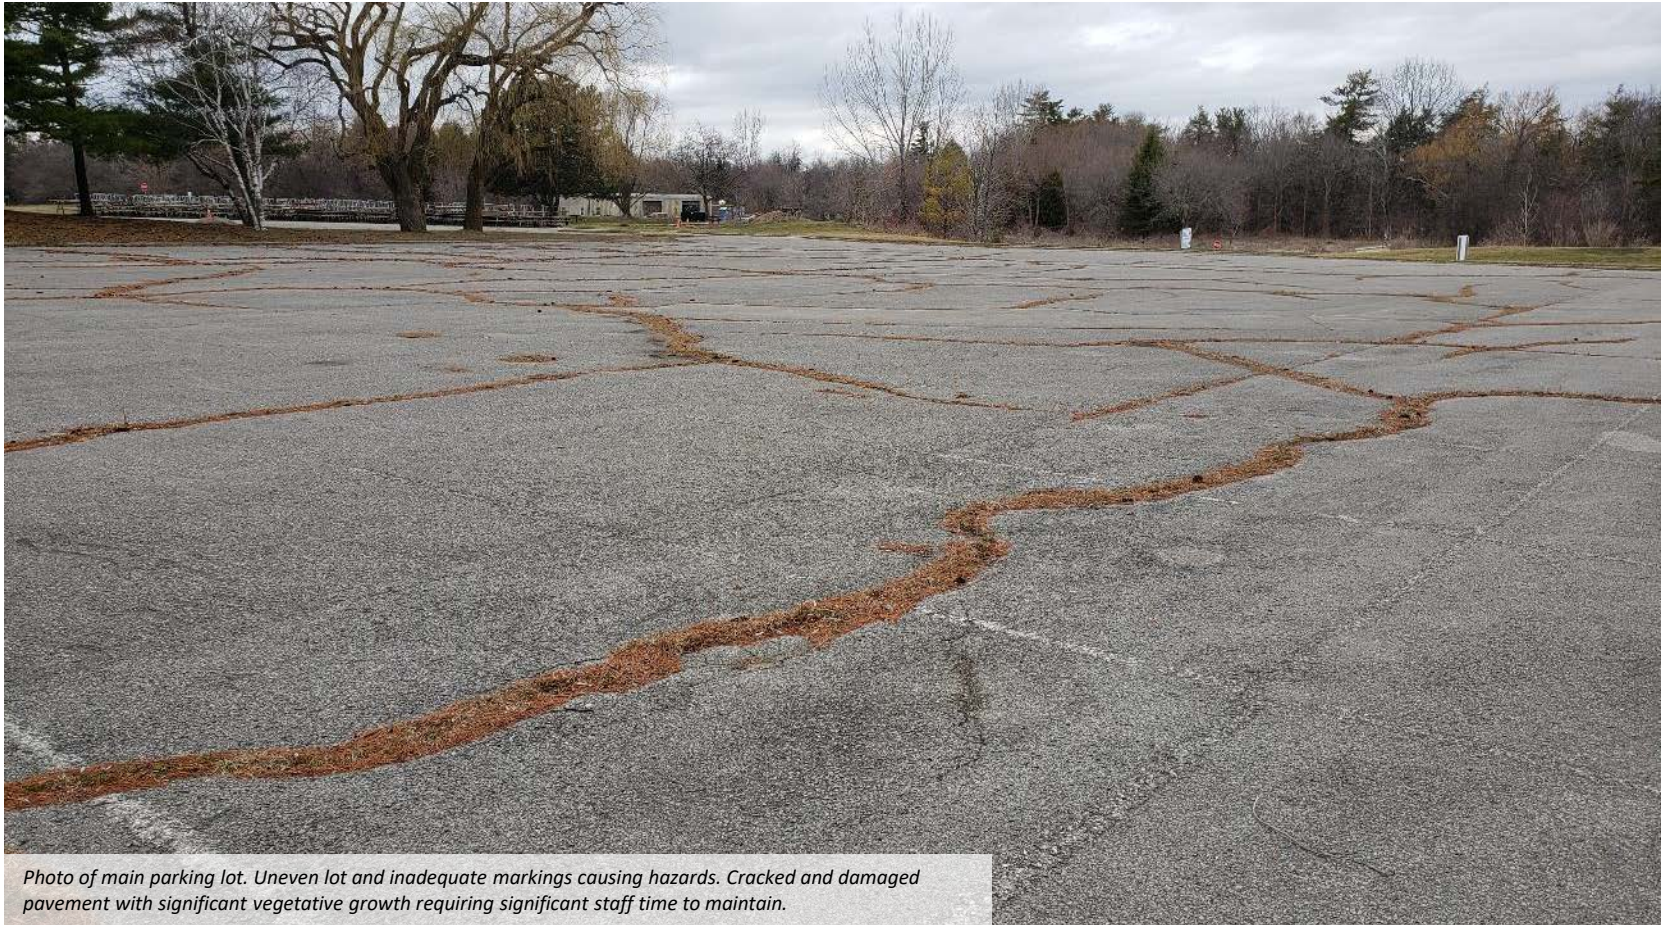
Photo of main parking lot. Uneven lot and inadequate markings causing hazards. Cracked and damaged pavement with significant vegetative growth requiring significant staff time to maintain.

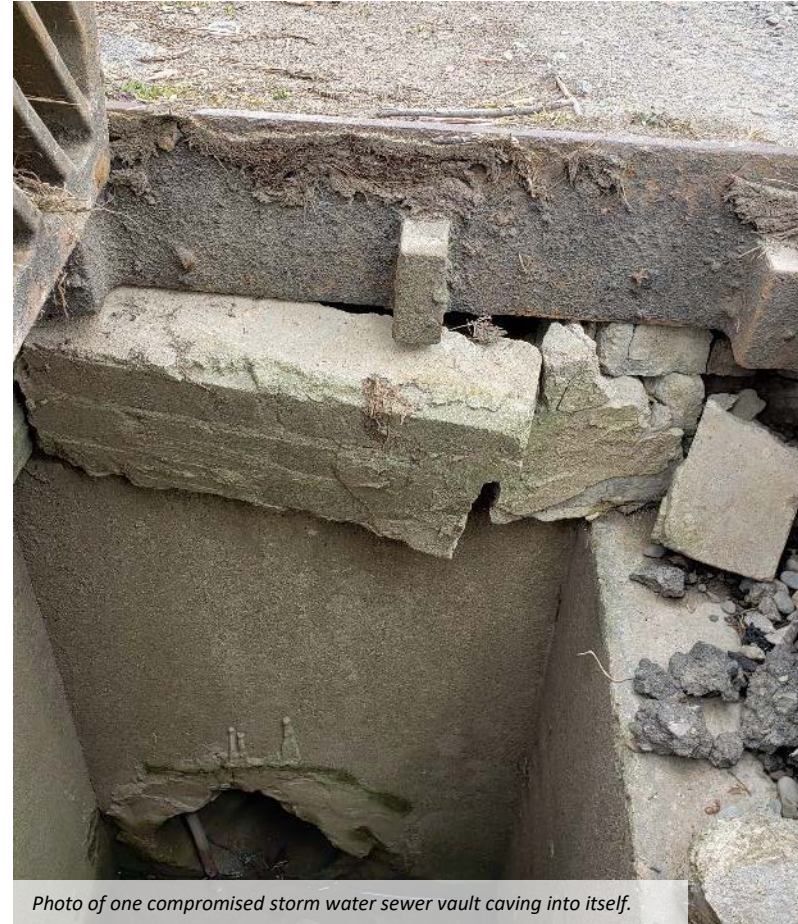
- Several Compromised Storm Sewer Drains:
 - Sewer walls collapsing into basin; sinking causing uneven roads and curb heaving leading to poor drainage
- Sink Hole in Parking Lot:
 - 3ft wide sink hole suspected to be due to abandoned well (floor found at ~40ft); contributing to parking hazards
- Moore's Meadow Picnic Site:
 - Large ground depressions requiring significant amounts of fill annually suspected to be due to abandoned infrastructure, including well

Photo of one compromised storm water sewer vault caving into itself.

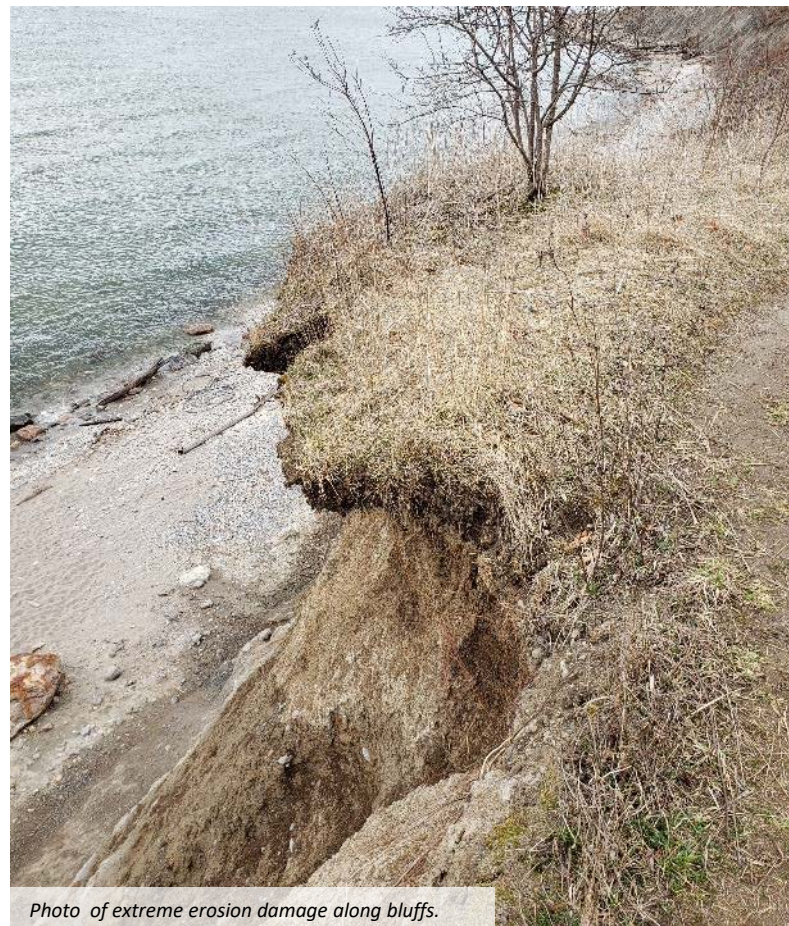
- Bluffs receded significantly over past 9+ years, 12-15 ft in some sections annually
- Unsanctioned trails close to trail edge have been signed closed; fences and signs consistently removed and vandalized to gain access.

Photo of extreme erosion damage along bluffs.

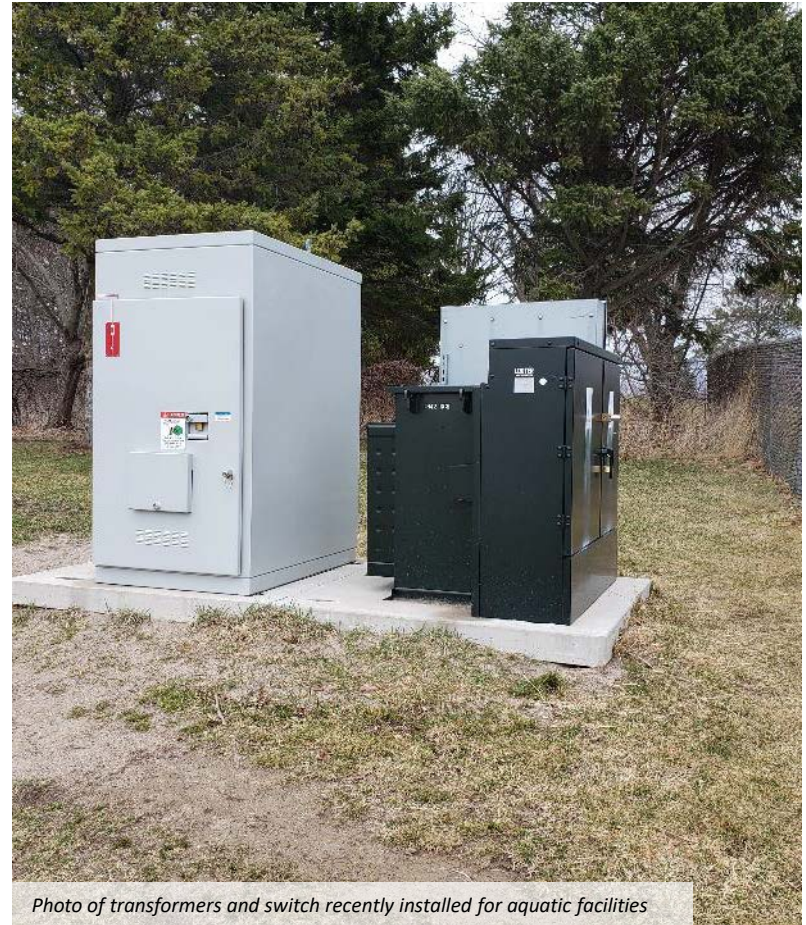
- Hydro upgrades: all panels, switches and transformers have been replaced and new underground electrical cables installed
- New shelter at the Aquatic Facility

Photo of transformers and switch recently installed for aquatic facilities

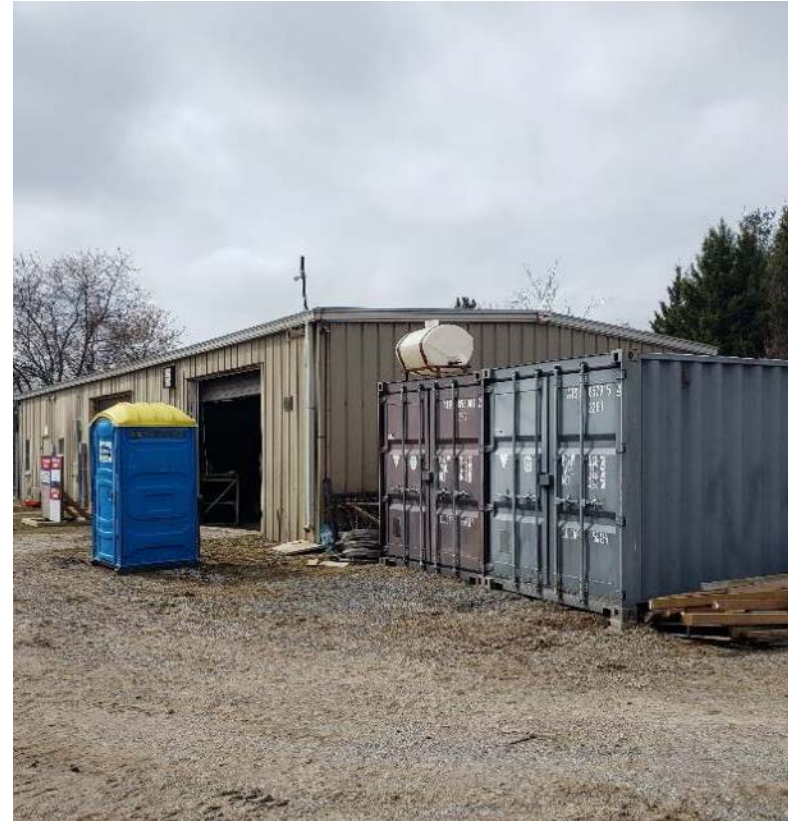
- Black mold, asbestos, and lead paint present
- Aging infrastructure and poor conditions of metal siding, roof, doors, and windows
- Water leaks in roof and improper grading results in water to flow across the floor in shop and lunchroom, and pooling in the shop
- Rodent nests and insects present as building is not weather-tight
- Storage space is limited, containers are used to supplement
- Executive Committee endorsement on April 9th, 2021 for release of \$523,000 in TRCA reserves to implement work

Photo of outside of workshop. Storage containers used due to limited storage space. Portable washrooms used in shoulder seasons because plumbing is not functional due to not having heat in workshop.
