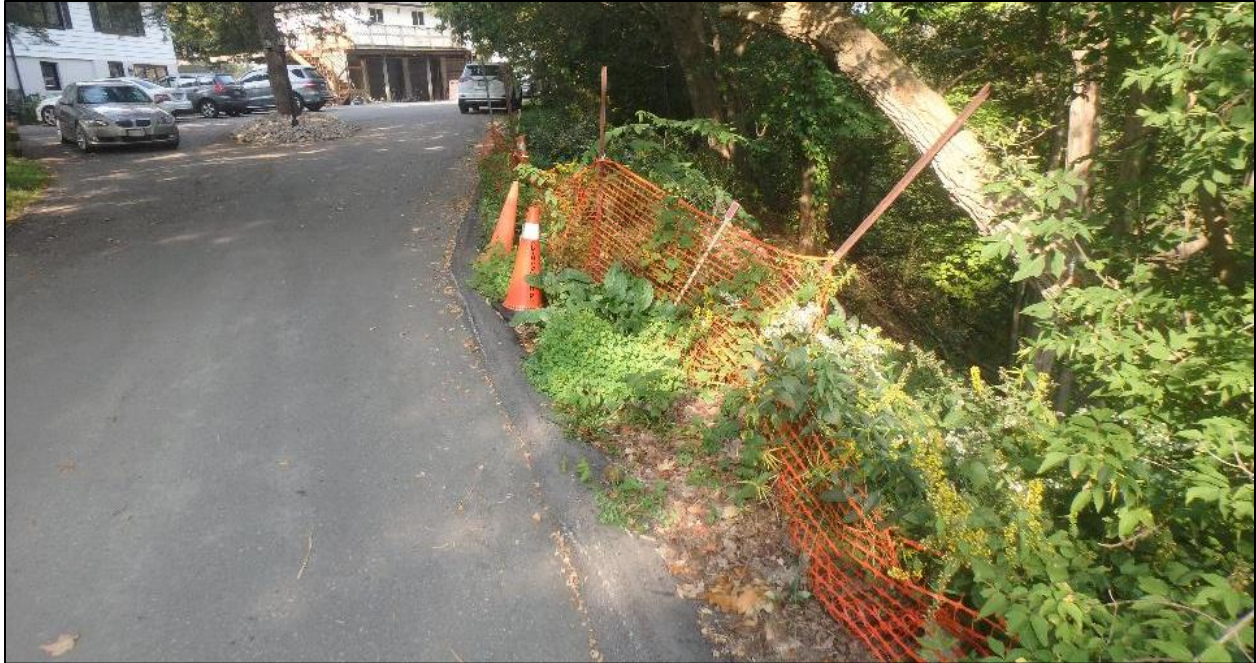
**Figure 1.** View of tableland conditions facing west; the erosion scour (surrounded by orange safety fencing) has grown in size since the initial inspection.

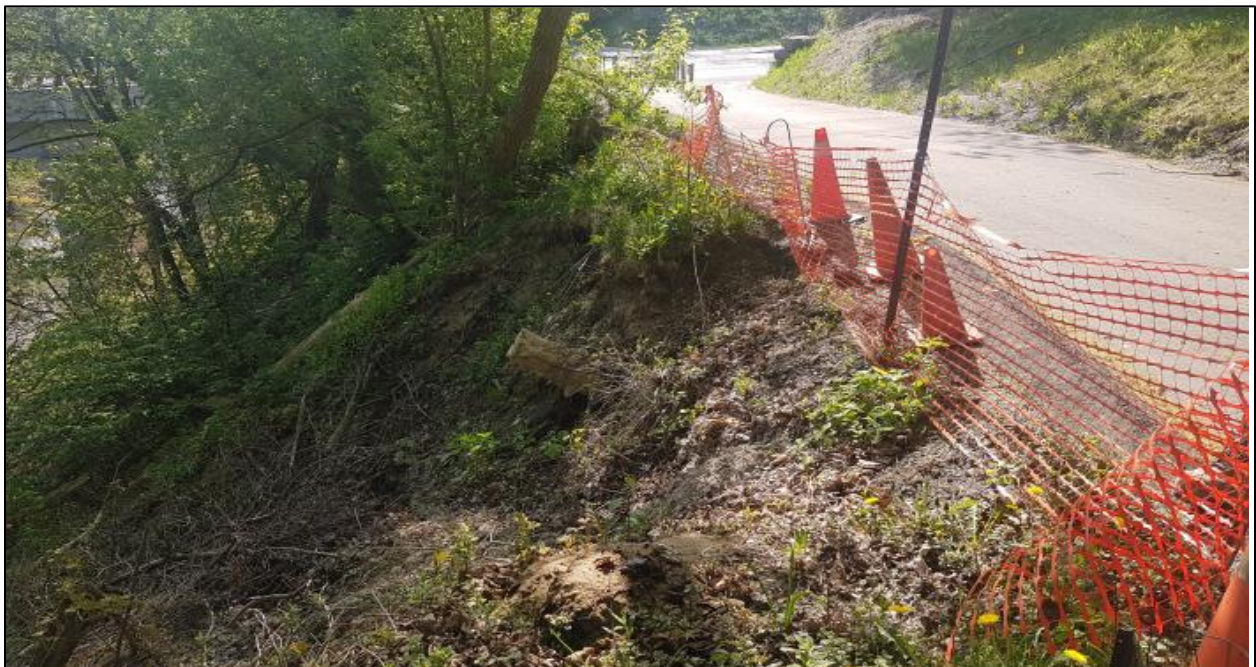
**Figure 2.** Slope crest with view of bare and unvegetated erosion scour on the slope crest facing east towards the Main Street South roadway.
