## Attachment 2 – Site Photos

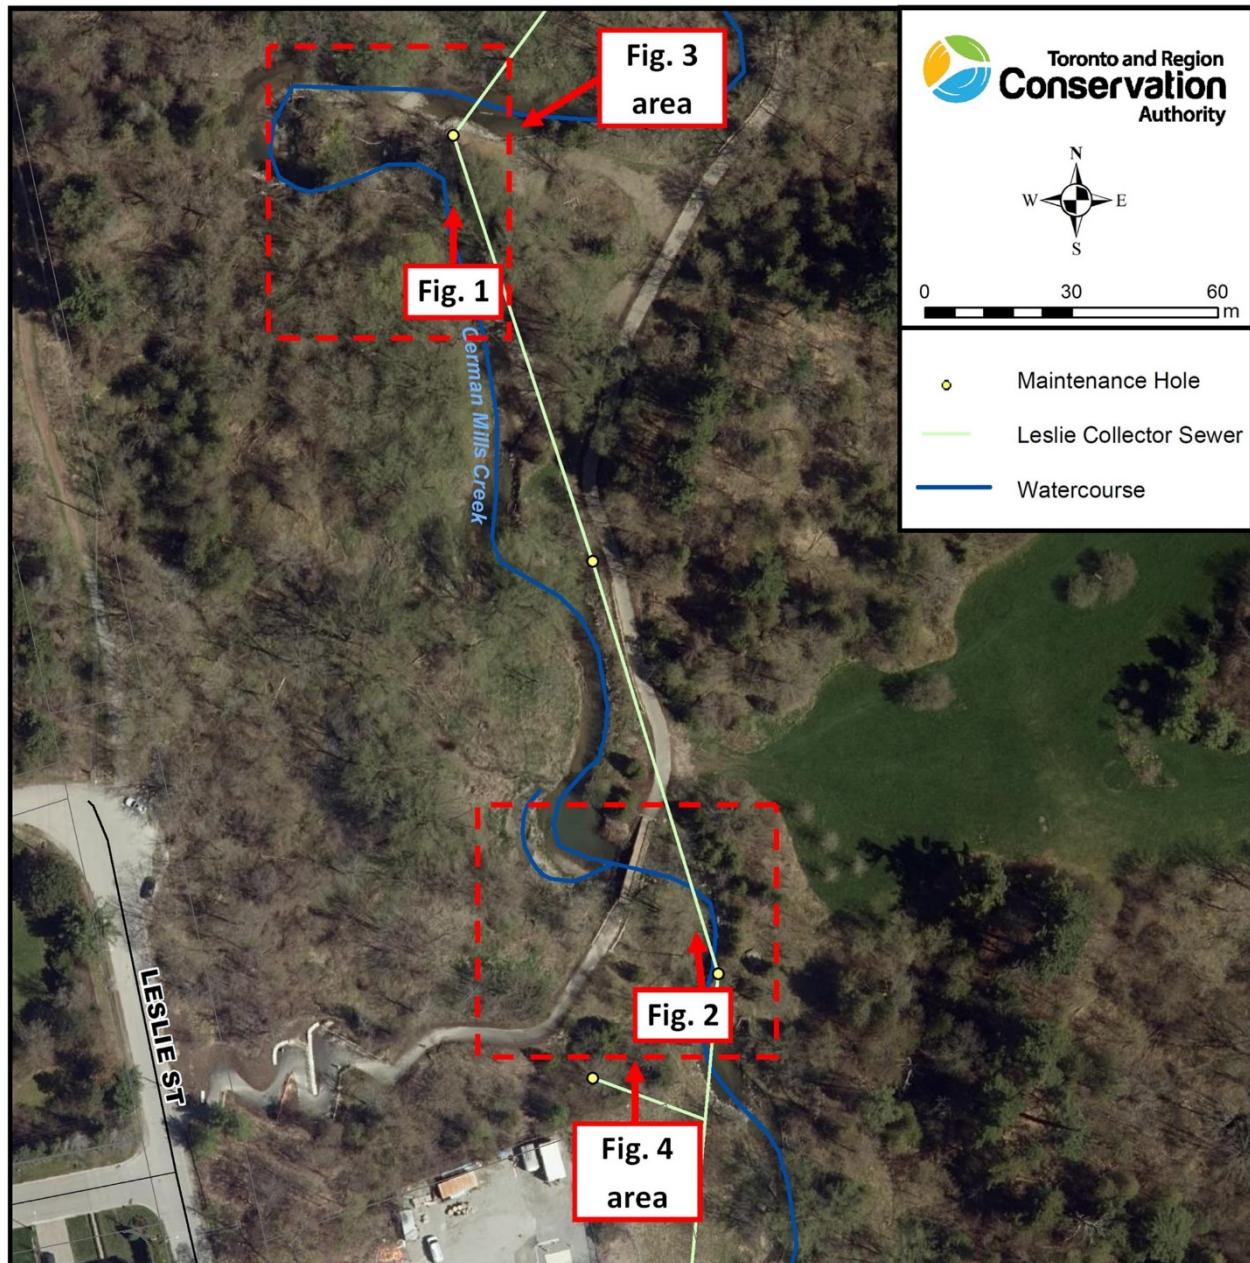
The above plan shows the approximate location and direction of photos from **Figure 1** and **Figure 2**, below. Dashed red boxes represent area of photo shown in aerial photographs from **Figure 3** and **Figure 4**, below.

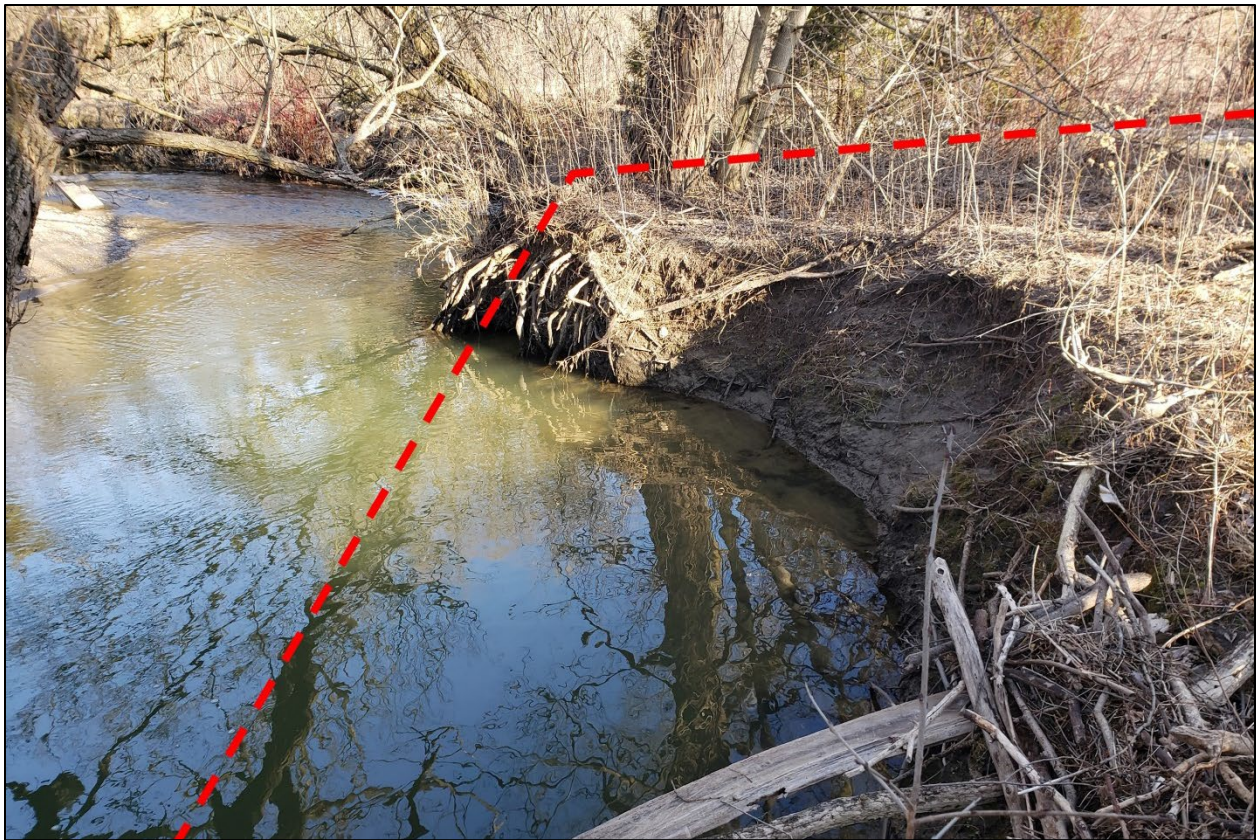
**Figure 1.** A bank scour and meander cut off is threatening the Leslie Collector sewer at German Mills Settlers Park Sanitary Protection Project Site 2-3. *Source: TRCA, 2020.*

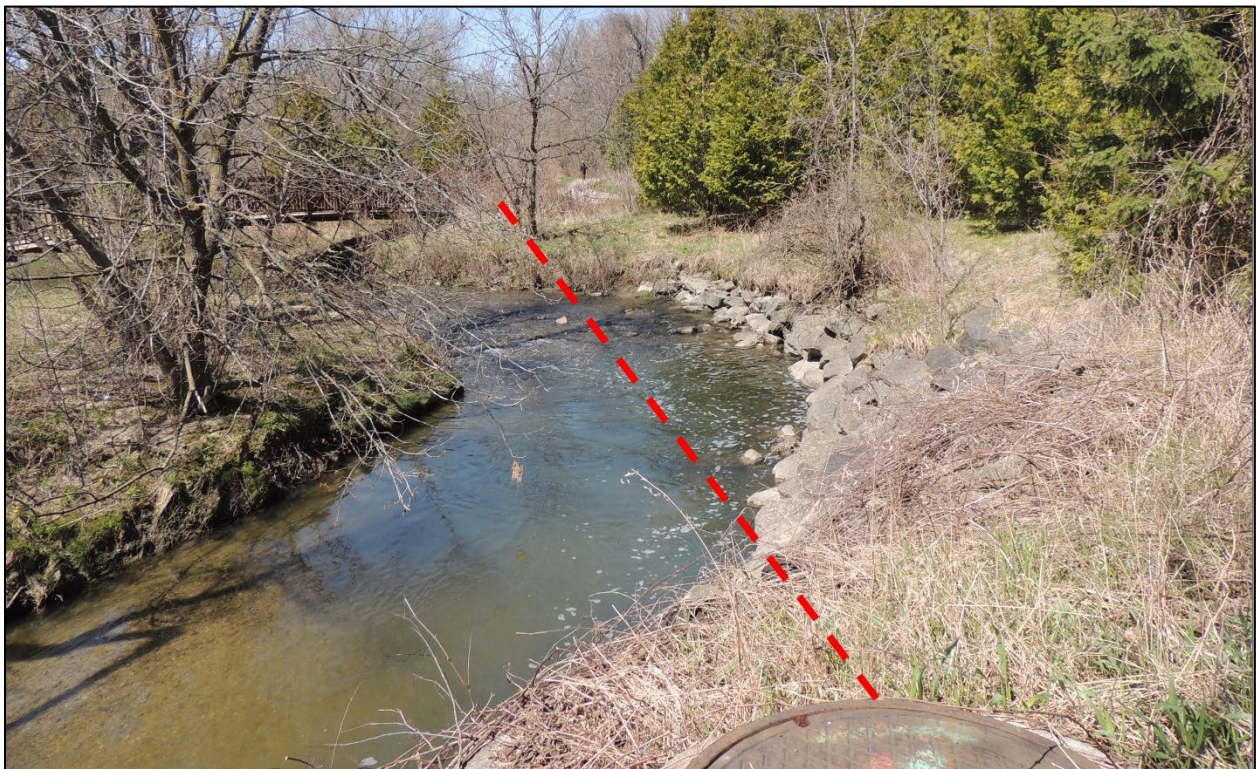
**Figure 2.** The Leslie Collector main and maintenance hole is at risk of erosion downstream of the pedestrian bridge in German Mills Settlers Park. *Source: TRCA, 2018.*

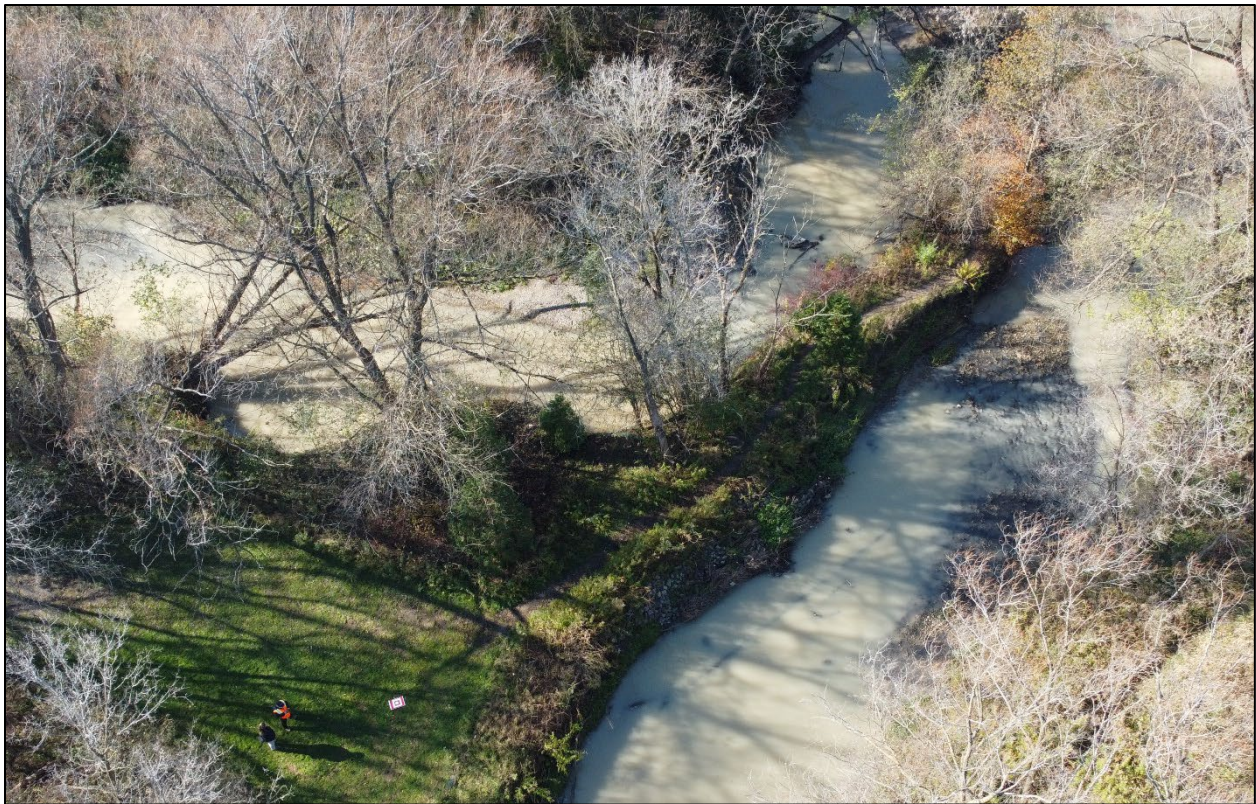
**Figure 3.** Aerial photo of the north end of project area where the Leslie Collector sewer is at risk from erosion. *Source: TRCA, 2021.*

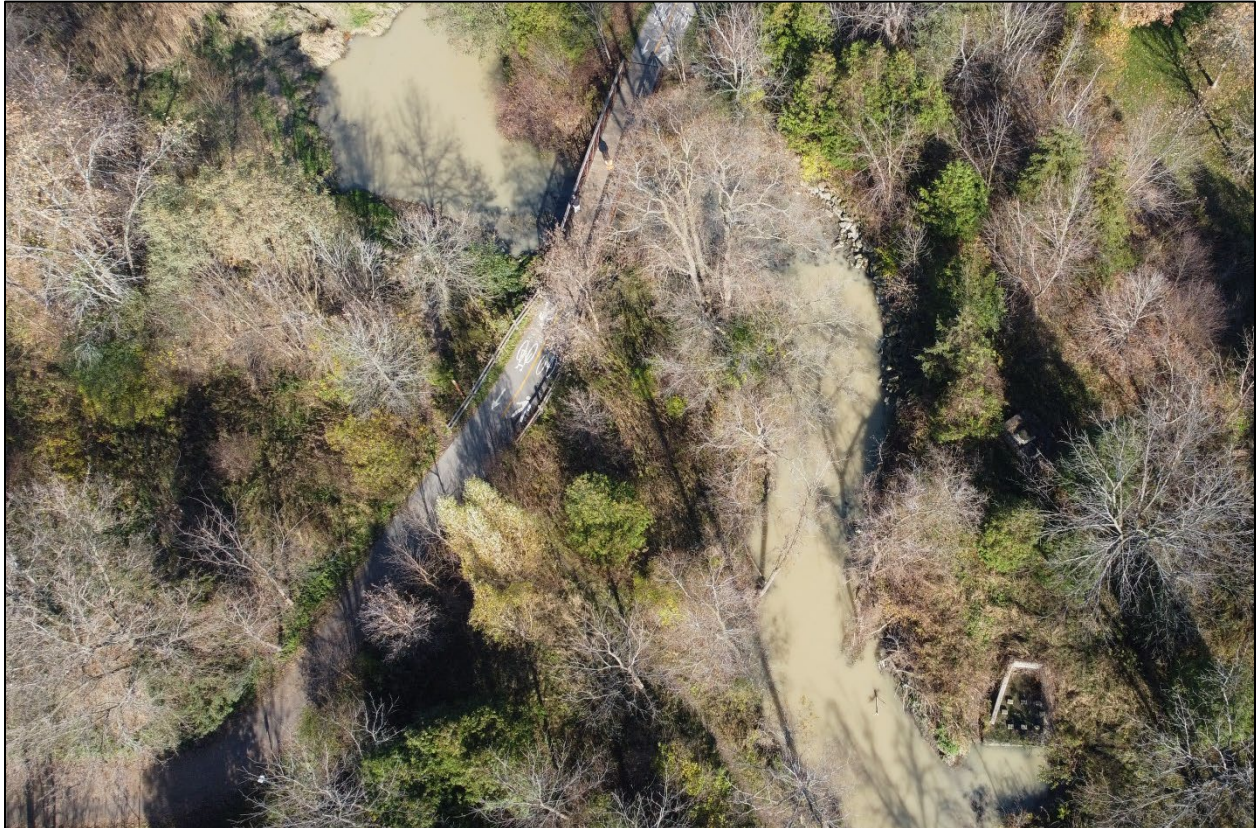
**Figure 4.** Aerial photo of the south end of project area where the Leslie Collector sewer, pedestrian bridge and trail are at risk of erosion. *Source: TRCA, 2021.*
