Attachment 4: Photographs of various TRCA flood infrastructure and projects

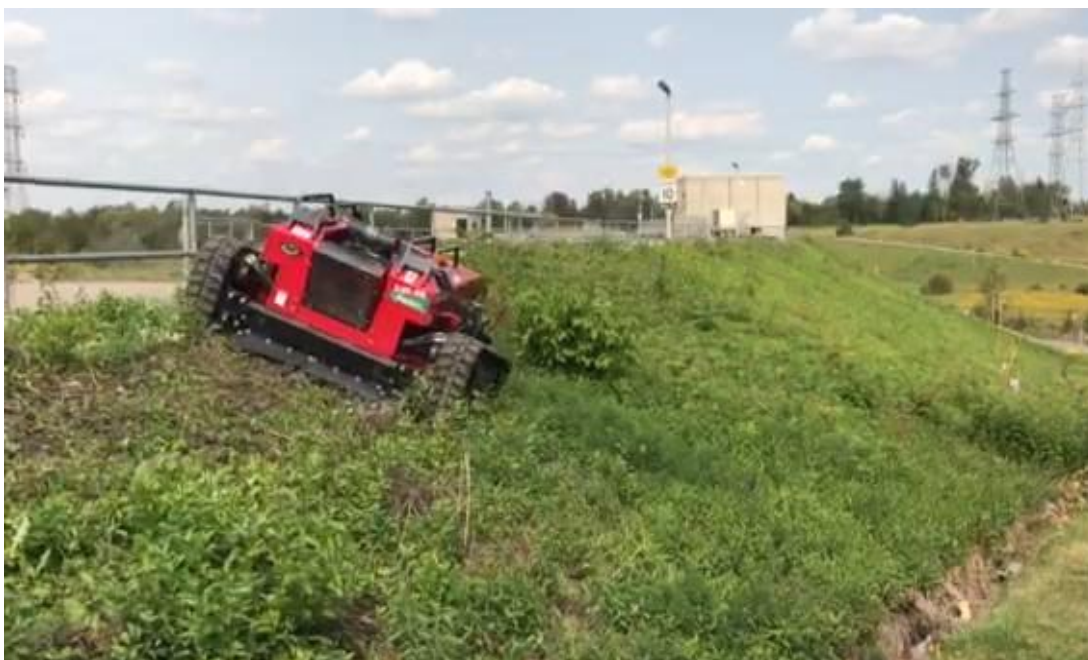
Figure 8 TRCA remote-controlled slope mower cutting the G. Ross Lord Dam embankment. This equipment allows very steep slopes to be maintained without putting staff at risk.
